TABLE OF CONTENTS

Airframe and General Structural Work

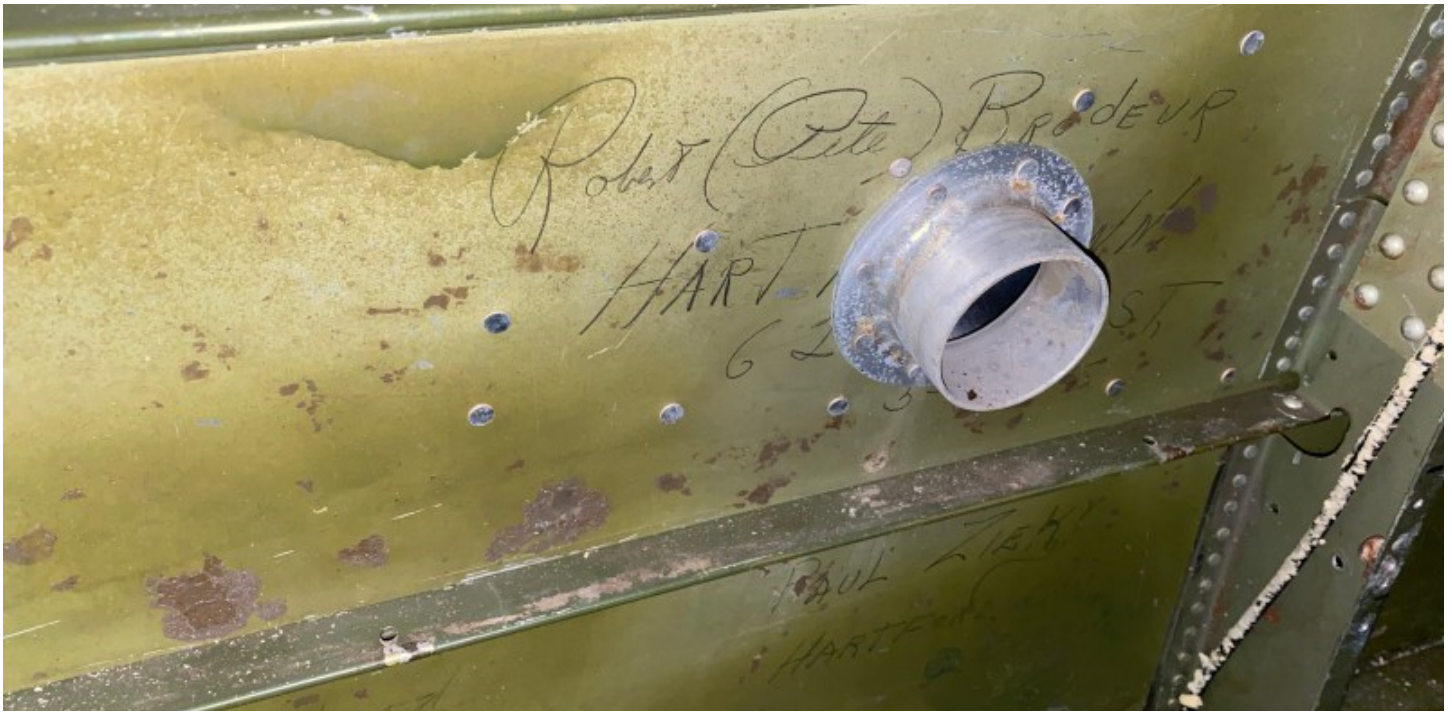
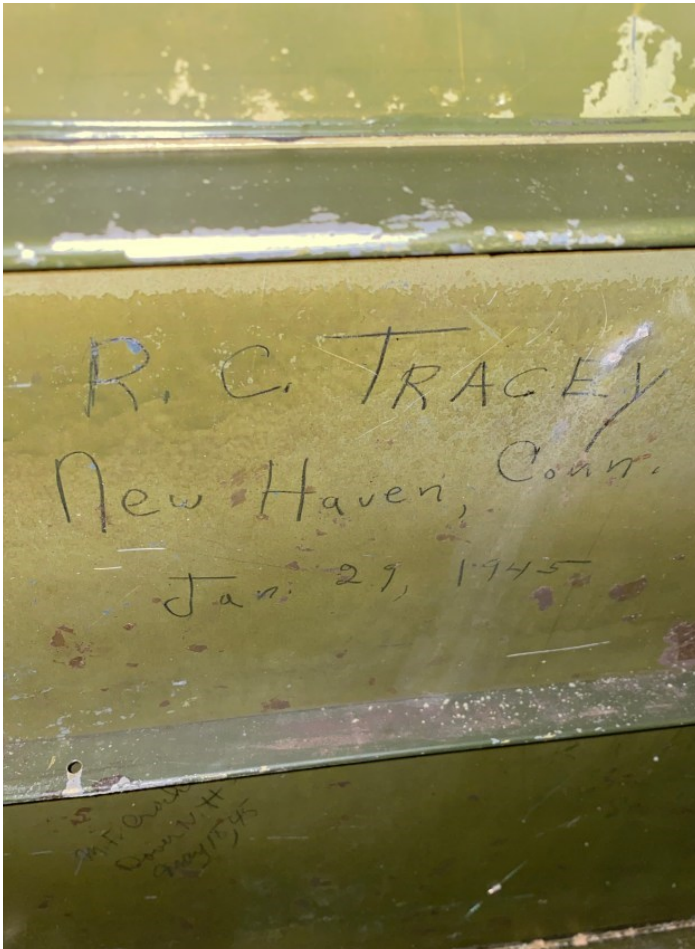
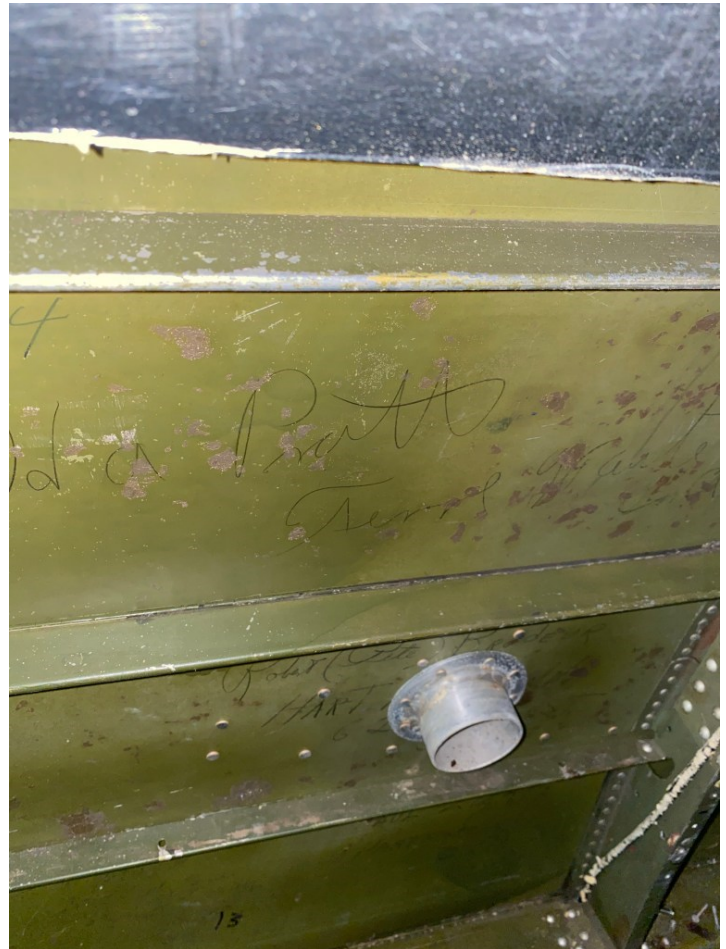
Upon its arrival in Aurora, the aircraft underwent immediate disassembly for comprehensive maintenance and upgrades. This process included thorough paint stripping to facilitate structural inspection and compliance with Airworthiness Directives (AD). Engines were carefully removed and inspected, while propellers were sent out for overhaul and compliance with AD requirements. Notably, during the disassembly and inspection phase, original crew member signatures were discovered under the old interior, which will be preserved and displayed as a testament to the aircraft's history.

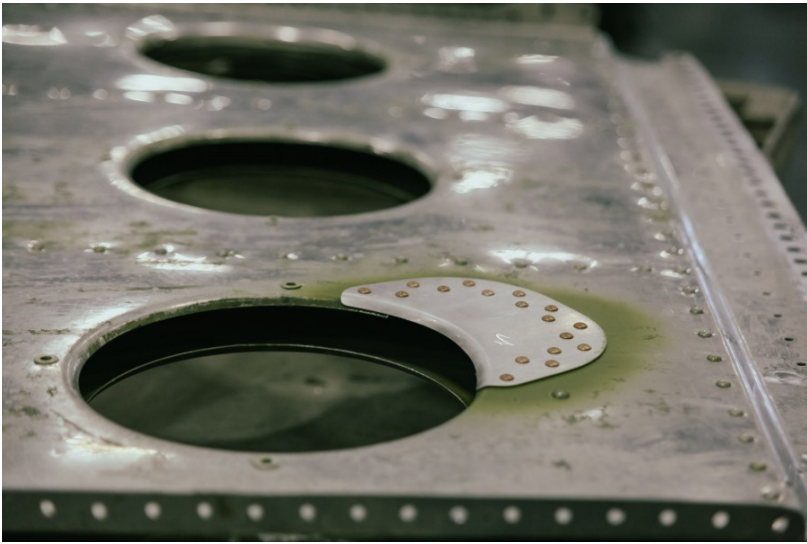
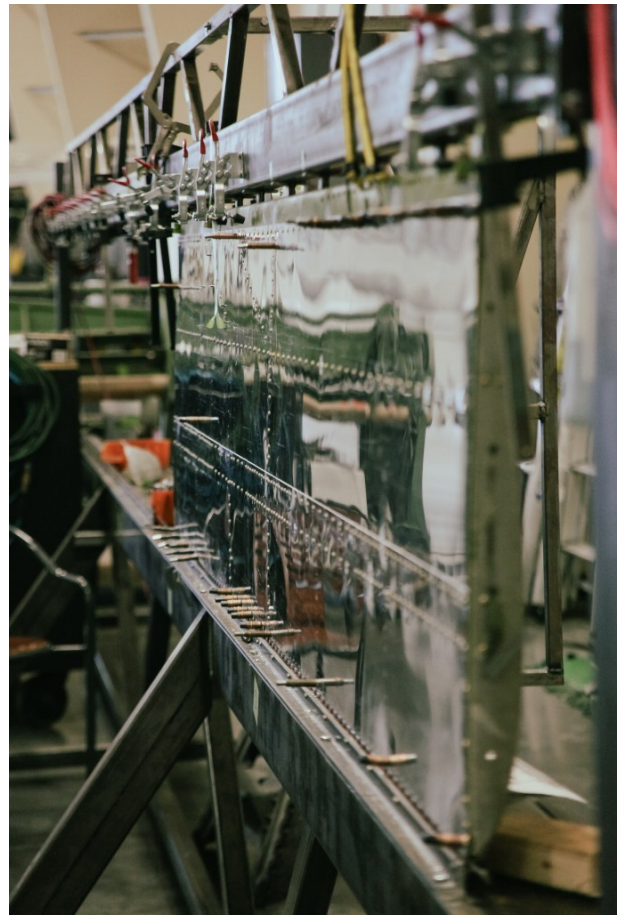
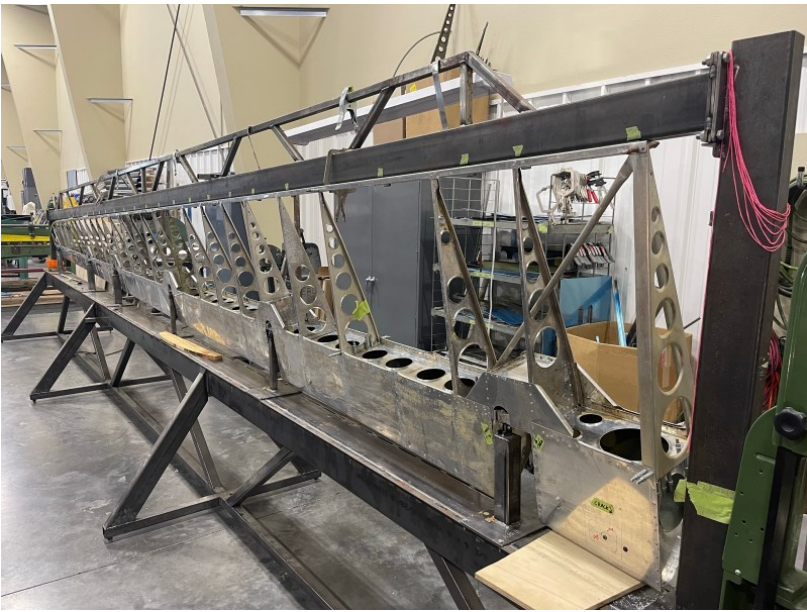
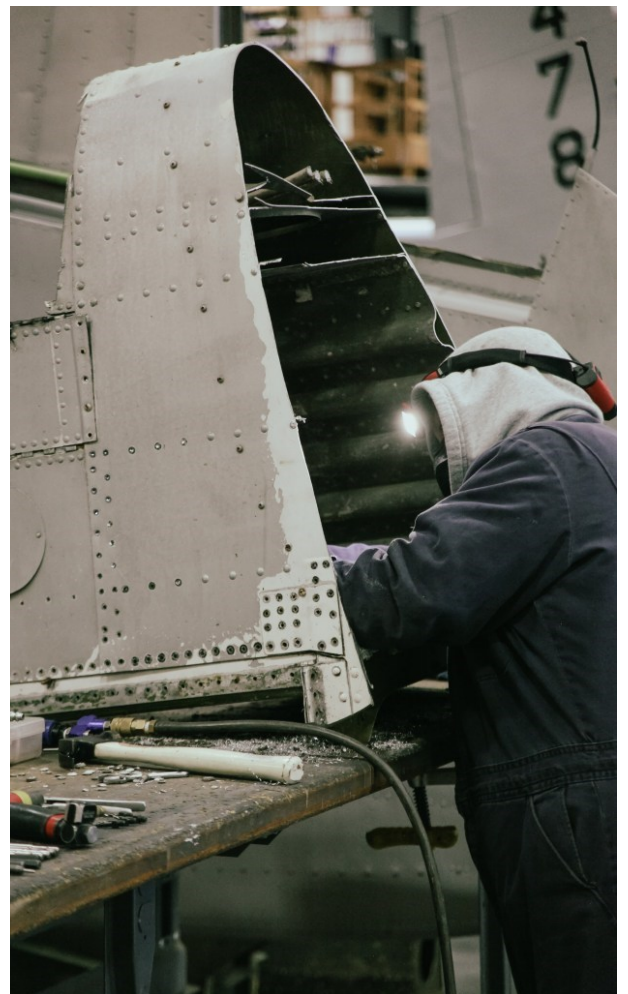
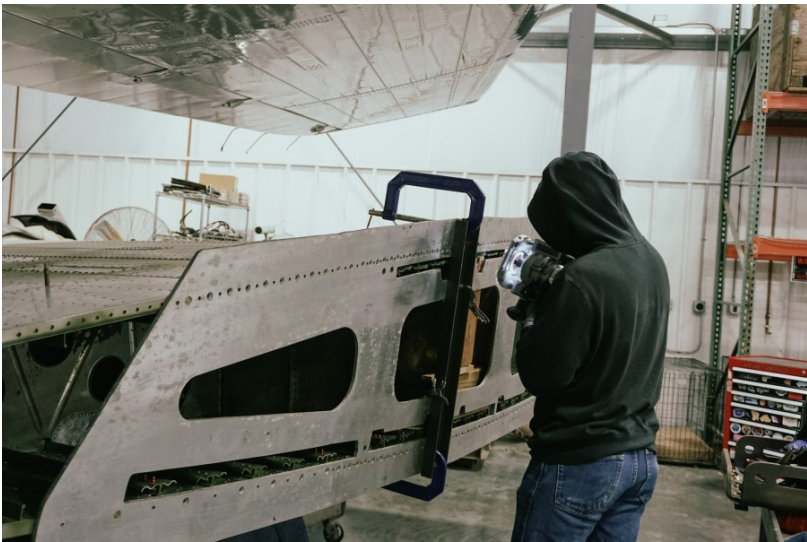
Airframe and General Structural Work

Significant repairs were undertaken across the airframe, addressing issues such as a center section repair necessitated by a previous heavy landing. Both left-wing spars underwent essential repairs, alongside numerous smaller structural fixes throughout the aircraft. The landing gear was completely rebuilt, transitioning from a bungee system to a hydraulic system for enhanced reliability and performance. Other notable improvements included the reskinning of the hamburger door and the installation of new fabric on the rudder and ailerons, as well as repairs to the elevators.

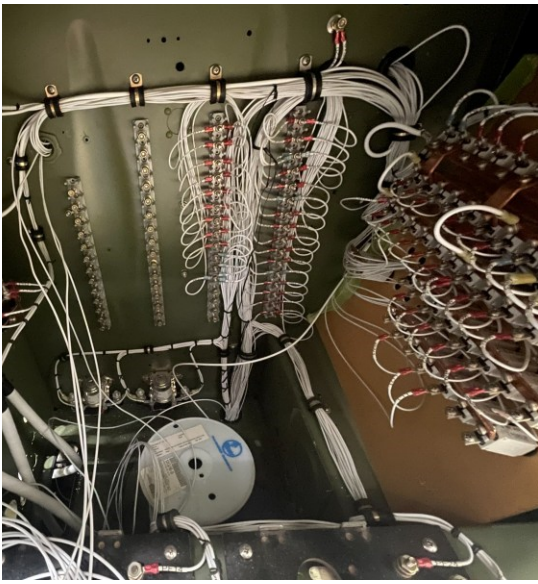
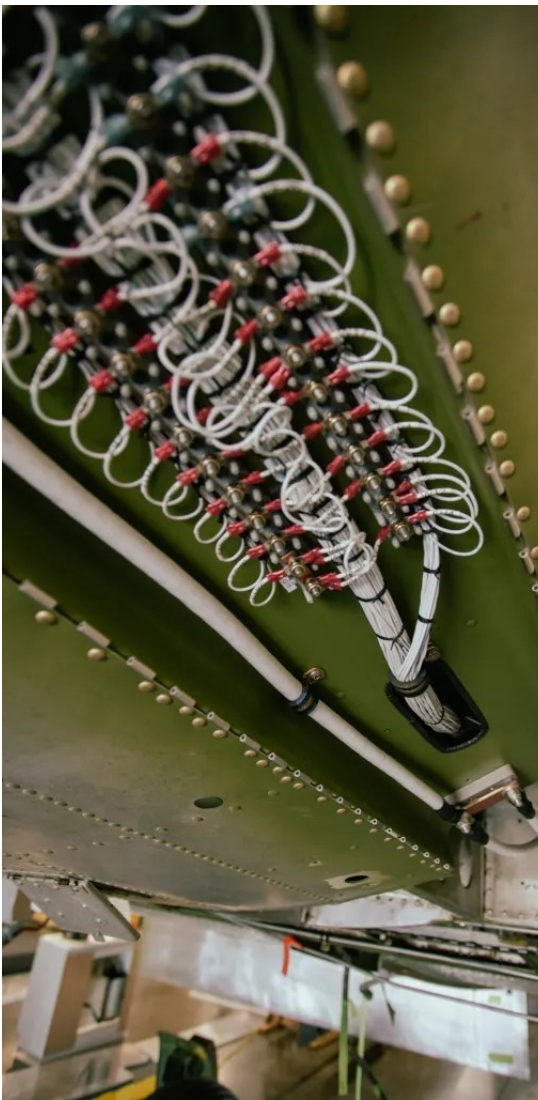
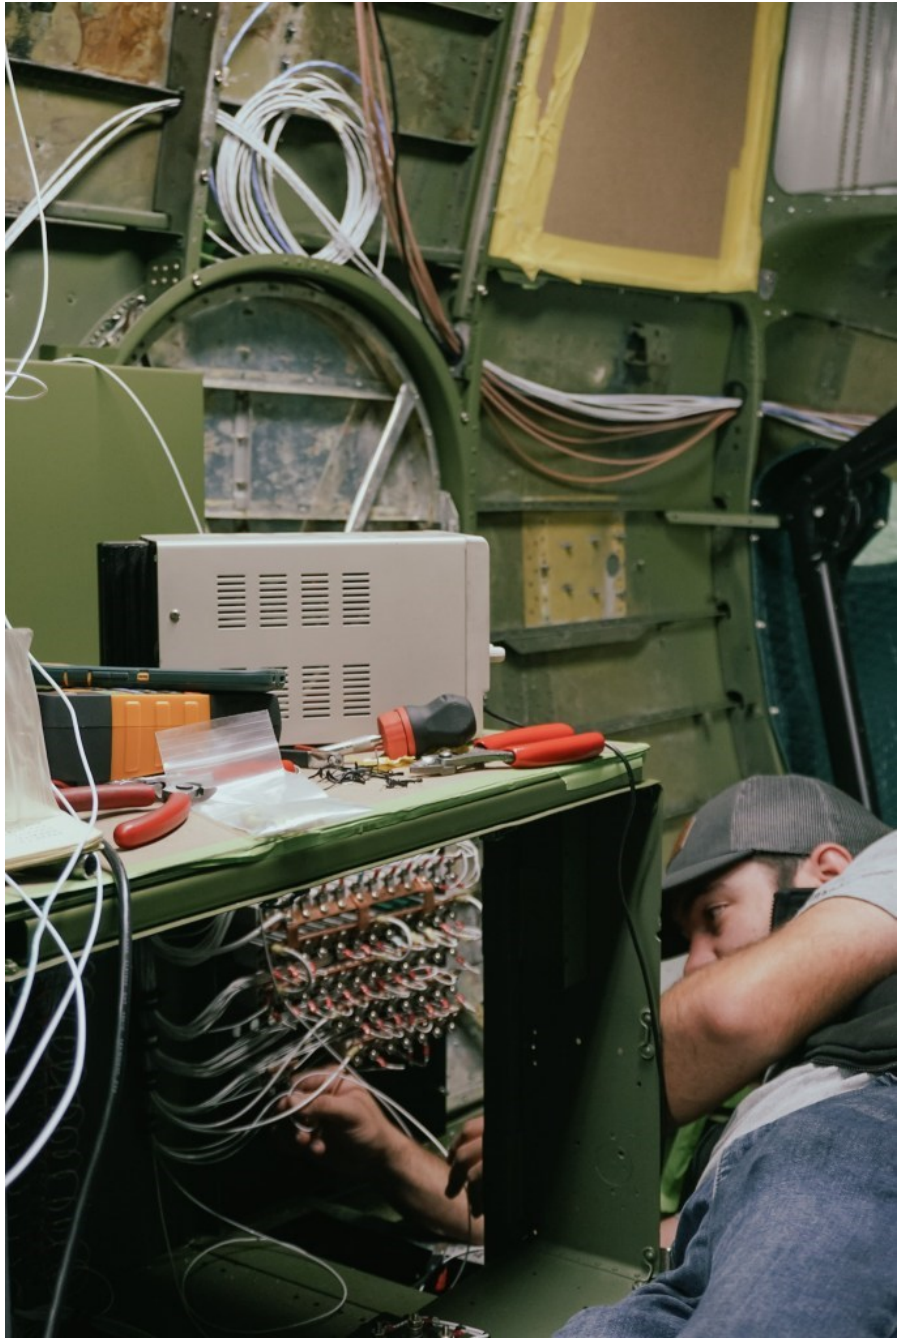
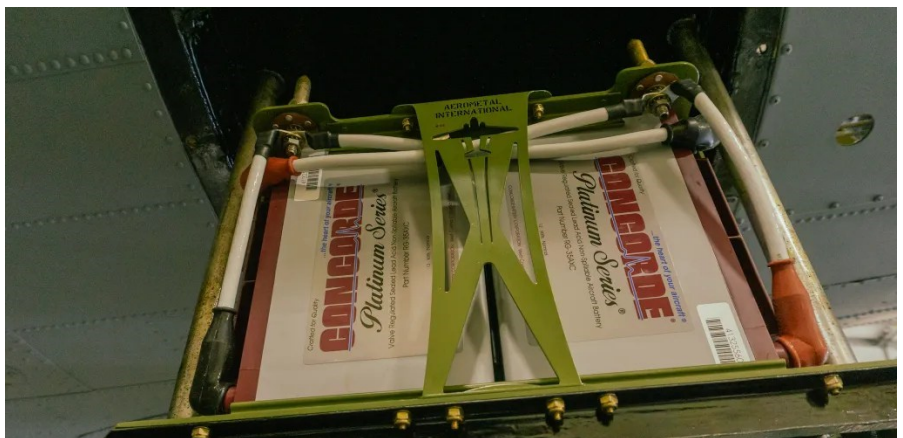
Electrical System

The restoration project commenced with the meticulous removal of the old electrical system, adhering strictly to the guidelines outlined in the Douglas manual. A new electrical cabinet was custom-built to modern standards, ensuring enhanced reliability and functionality. Electric and fluid line trunk panels were meticulously cleaned and repainted, maintaining the aircraft's integrity while meeting stringent safety standards. Additionally, extensive rewiring was conducted in the wheel wells, complemented by the installation of chip detectors, further bolstering operational safety.

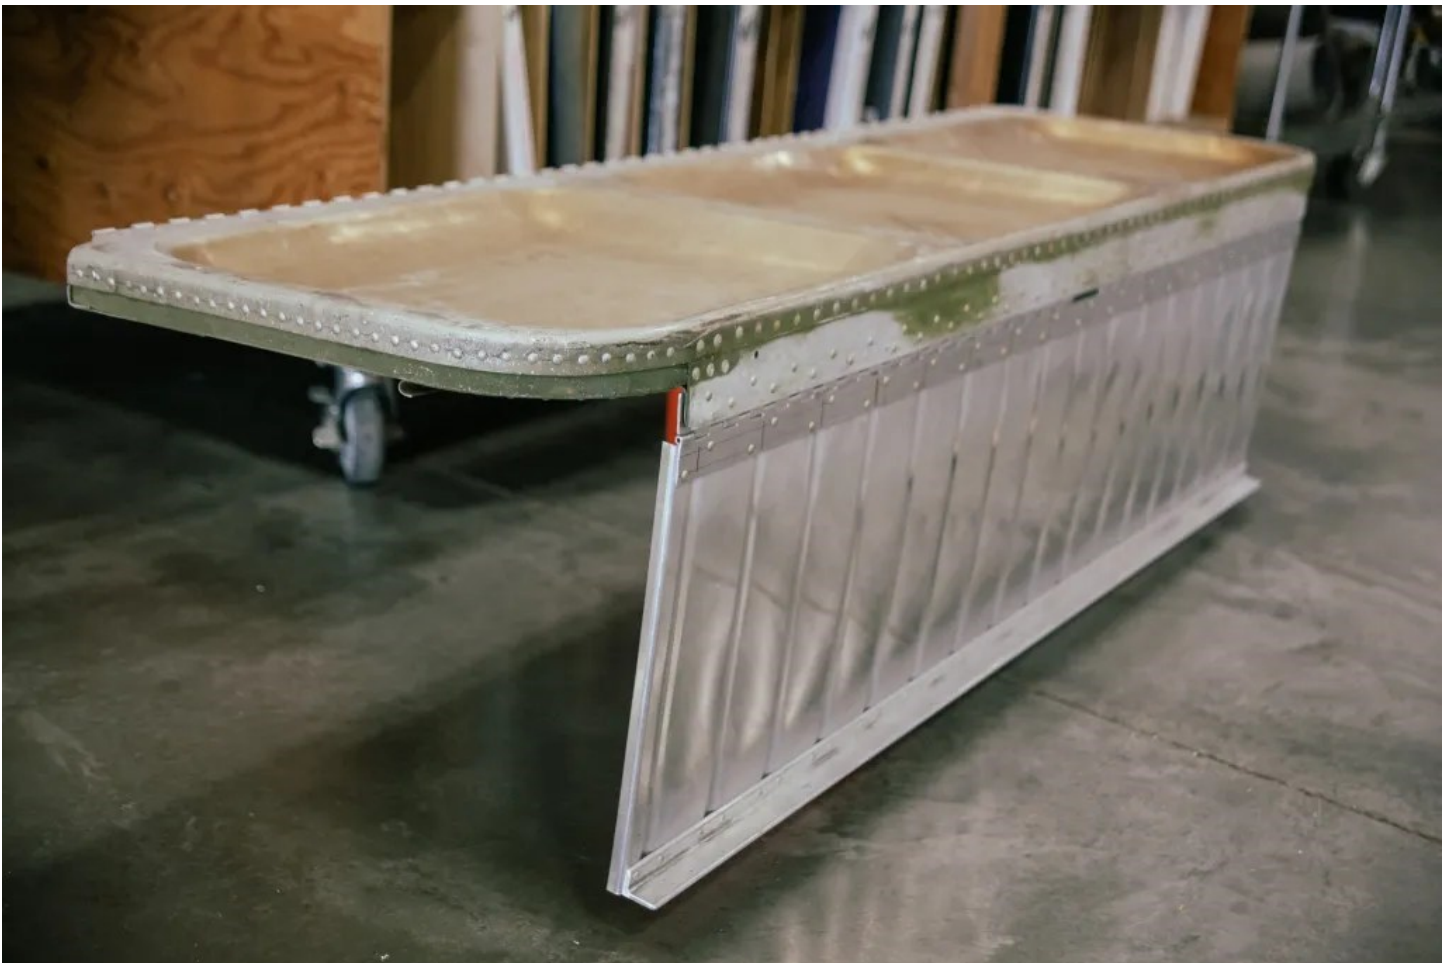
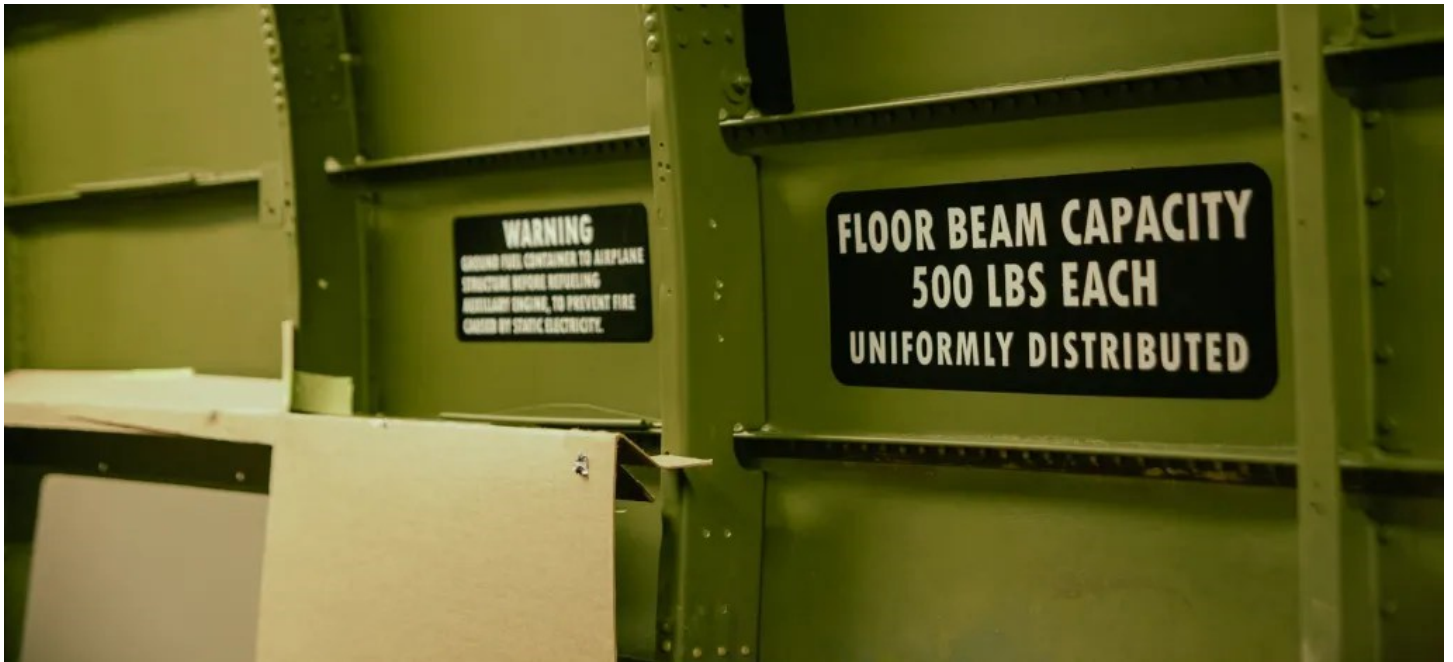
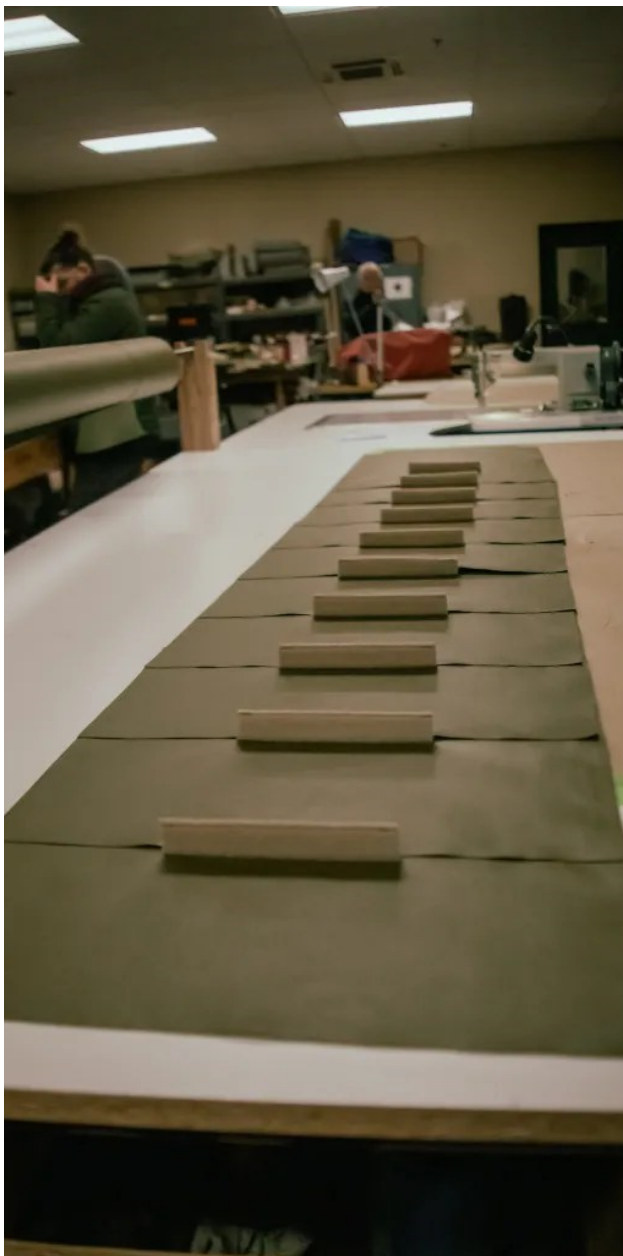
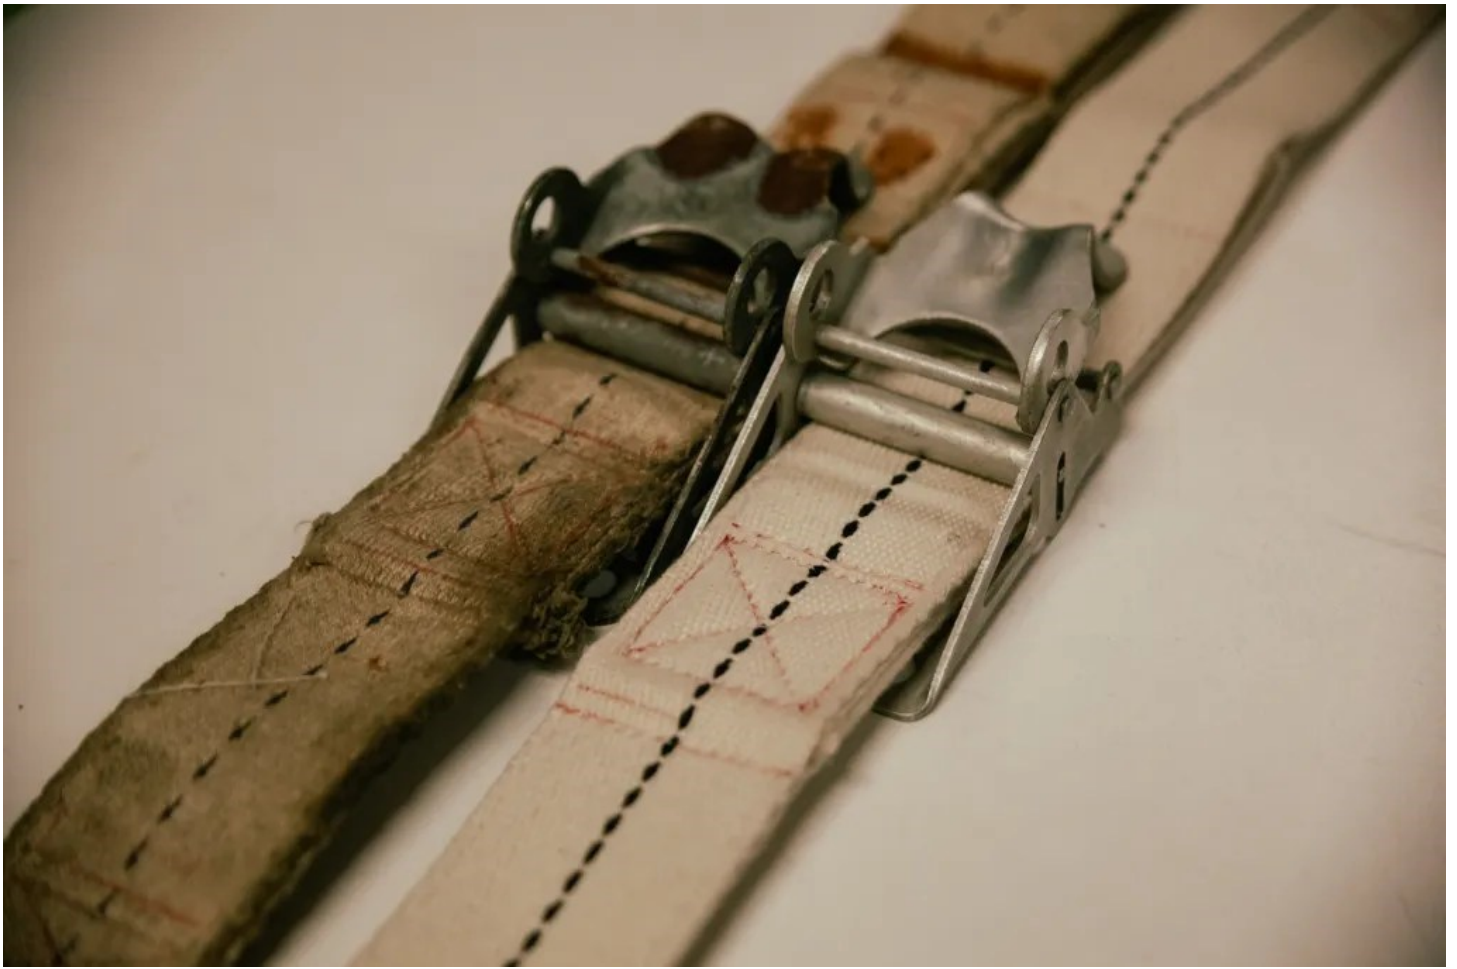
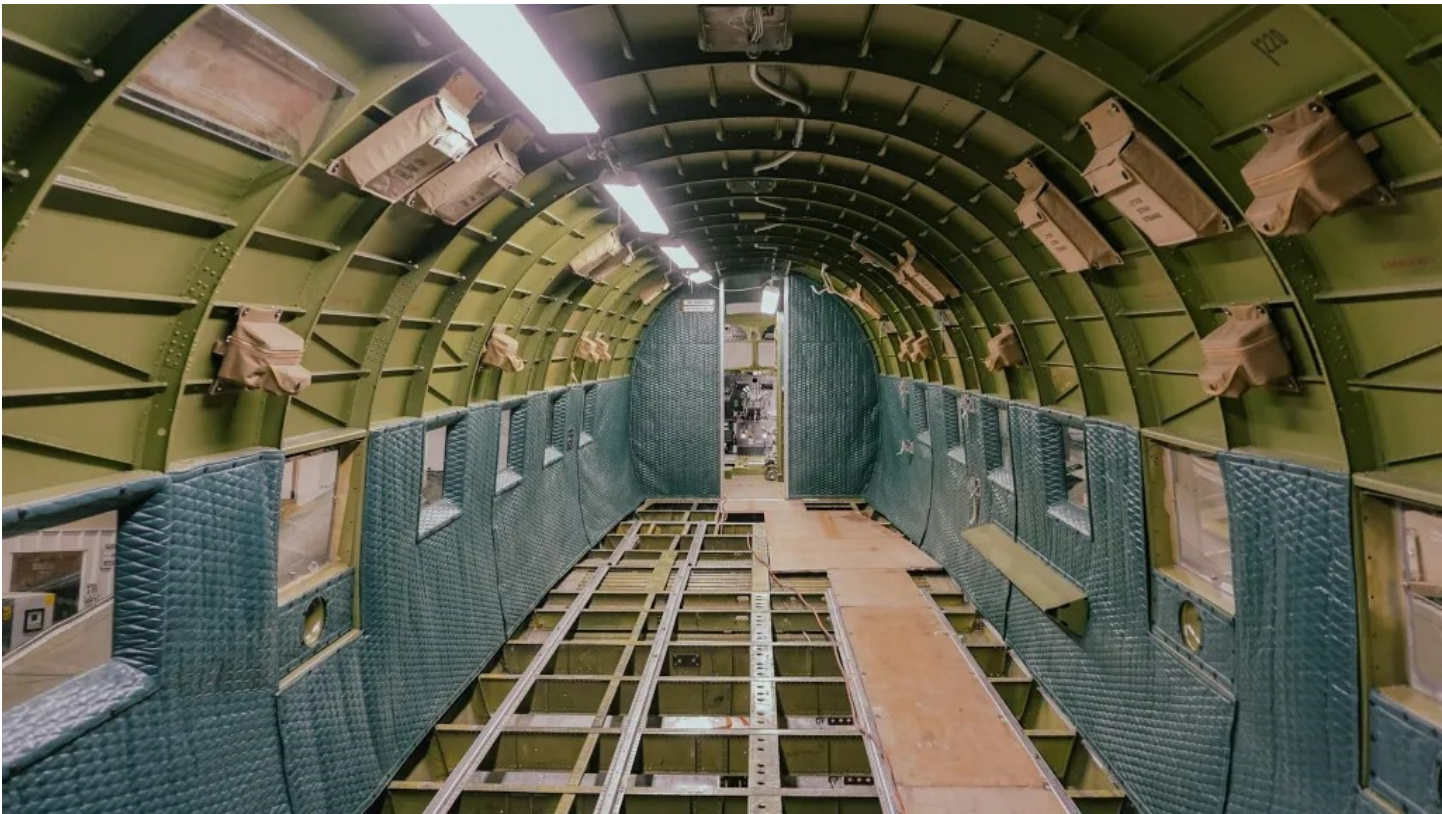
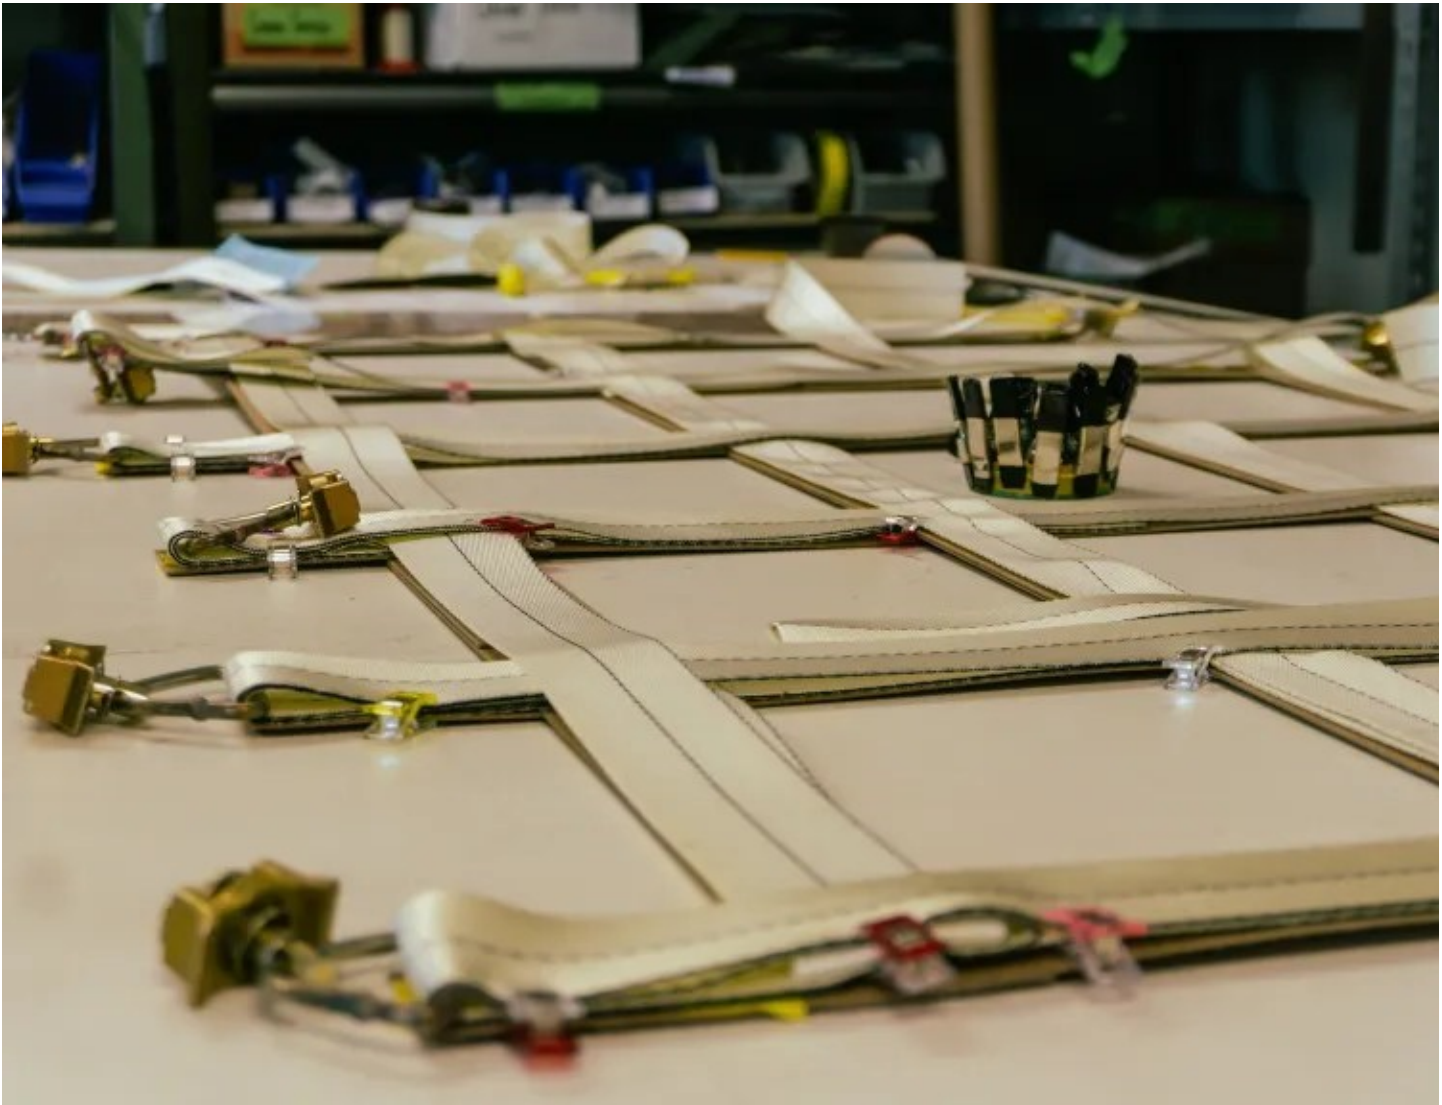
Interior Restoration

The interior restoration focused on preserving historical accuracy while enhancing comfort and functionality. Original interior load section markings were meticulously replicated using stencils and sponge stamping, maintaining the aircraft's authenticity. The control quadrant was assembled and installed, awaiting the precise installation of control cables. Unique additions included the reproduction of an original Litter Strap assembly and retrofitting a three-place paratroop seat for installation in the main cabin. Upholstery work progressed with meticulous attention to detail, ensuring that passenger seat cushions and interior furnishings were crafted according to the original Douglas blueprints, combining historical authenticity with modern comfort.
