TABLE OF CONTENTS

Airframe and General Structural Work

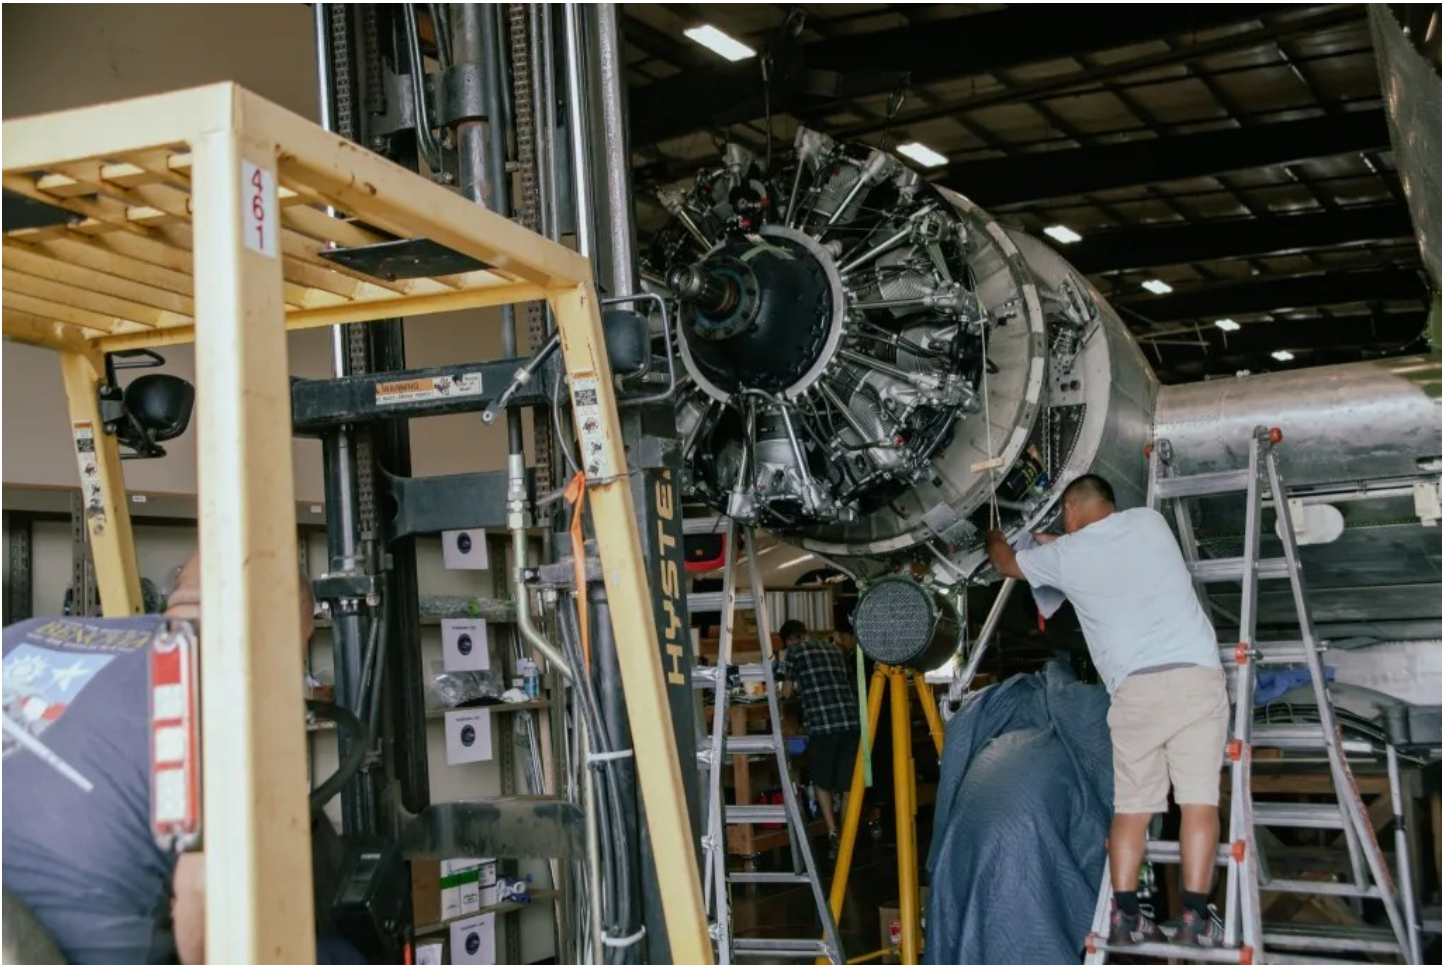
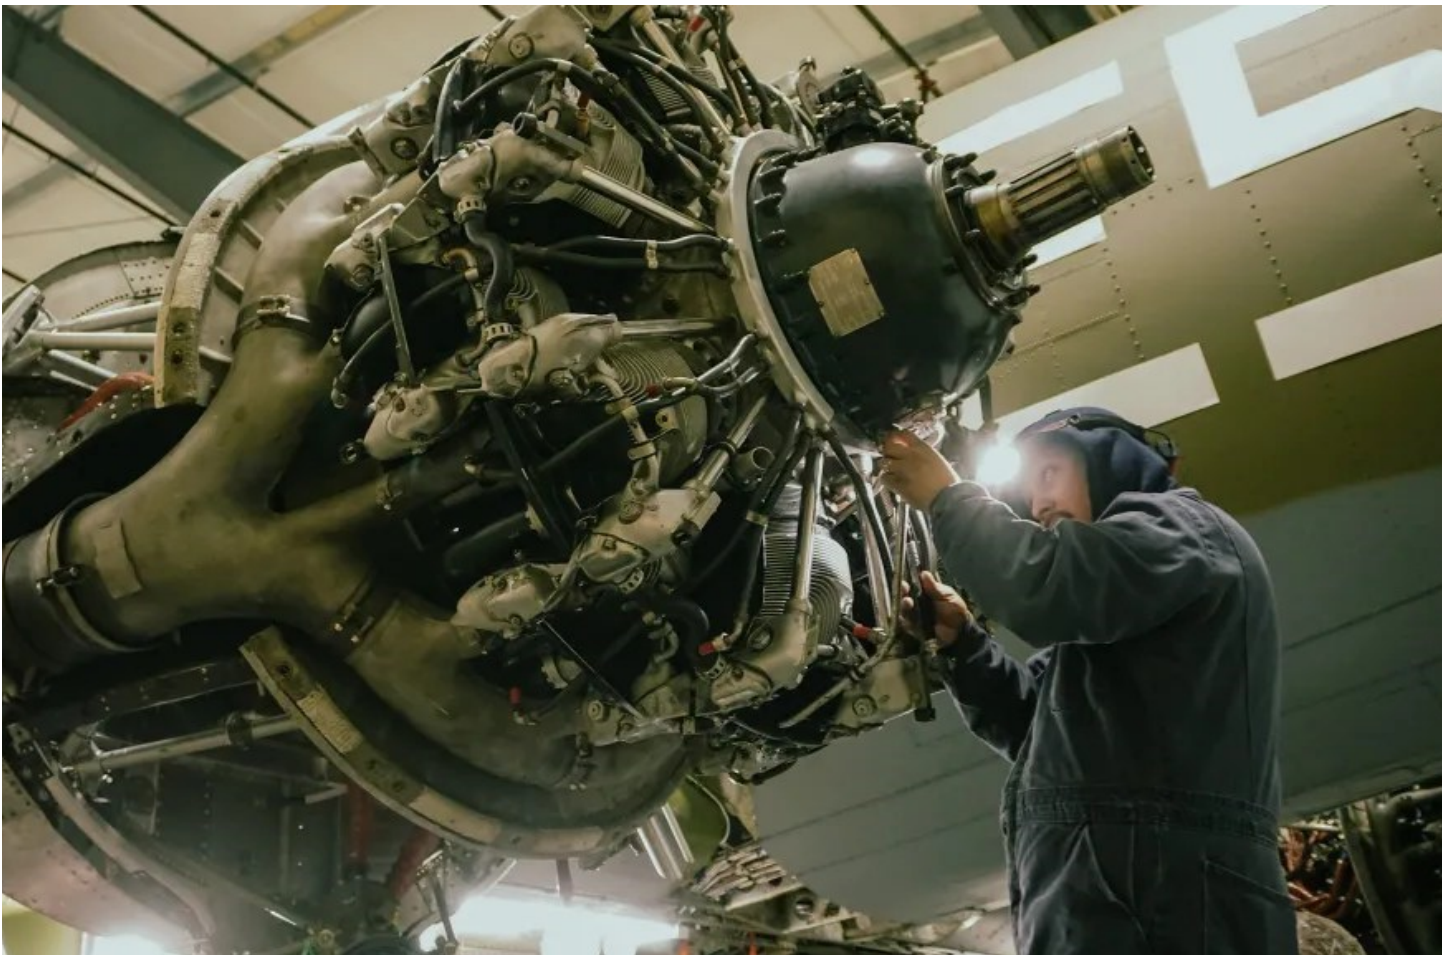
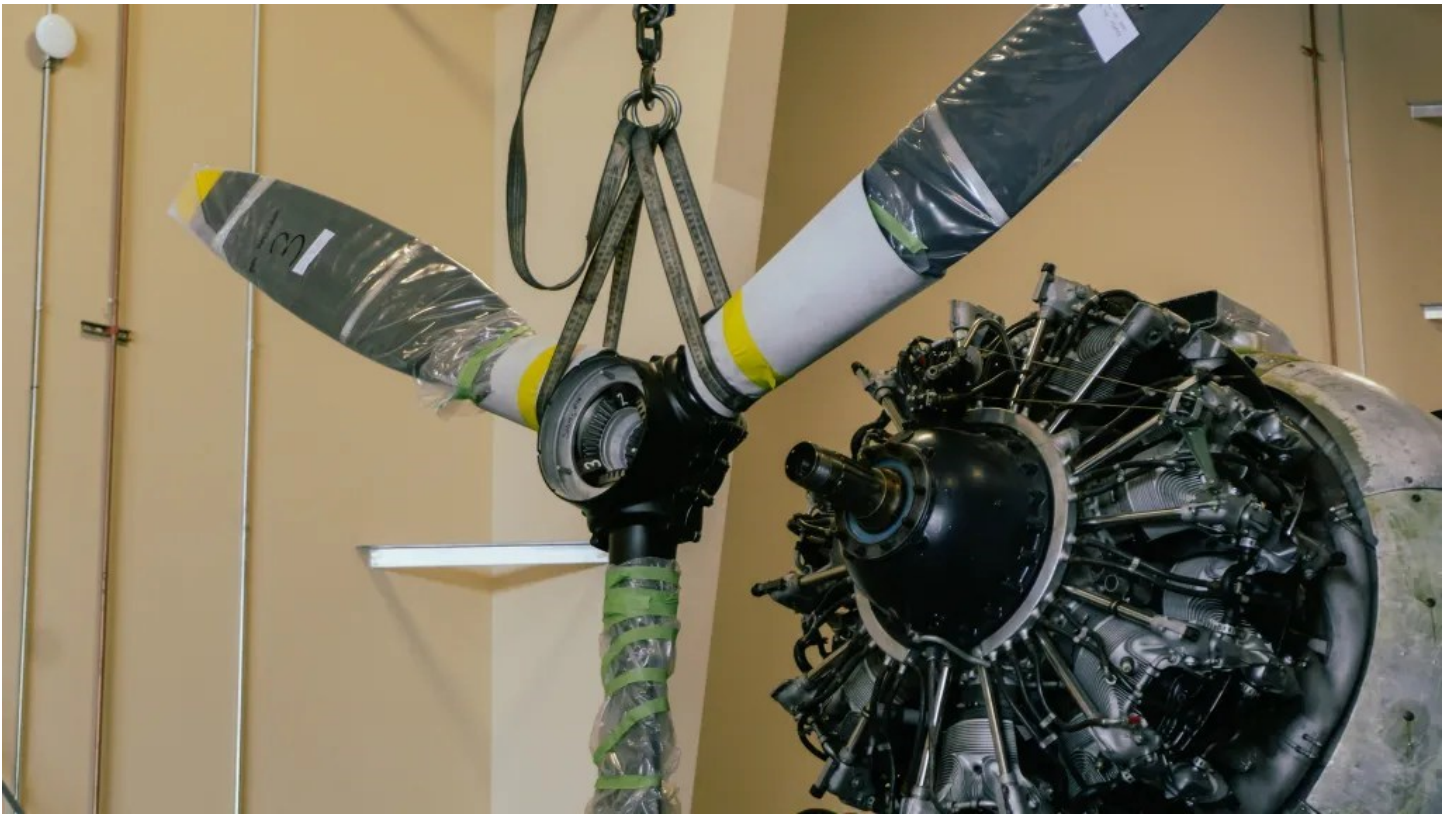
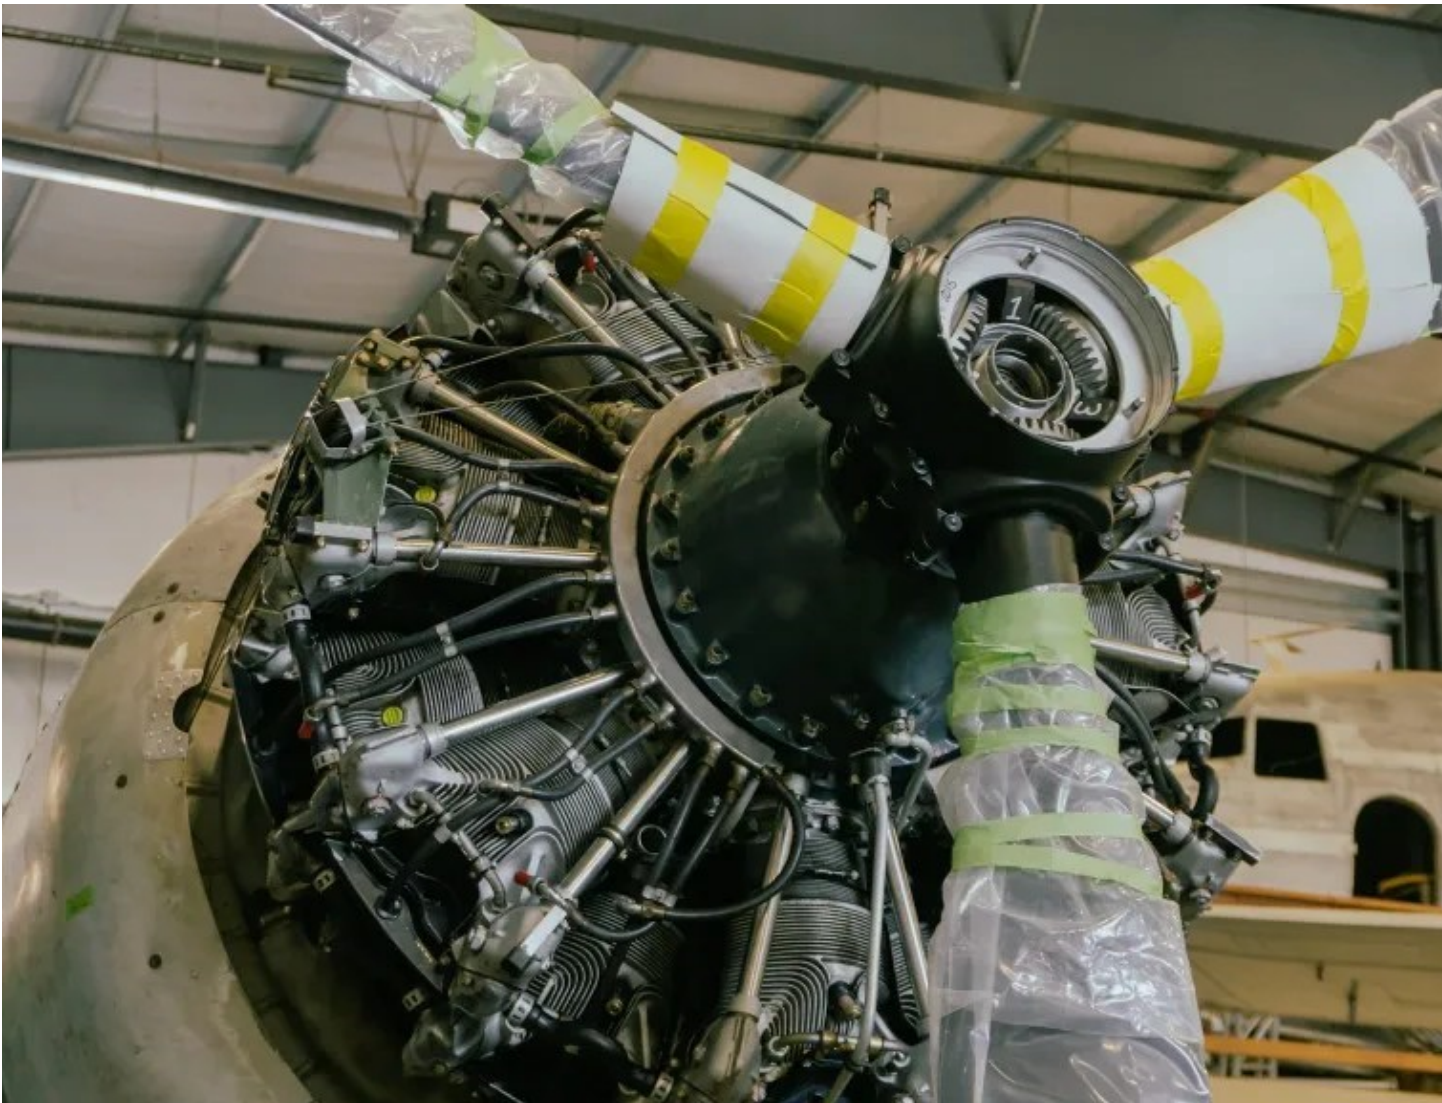
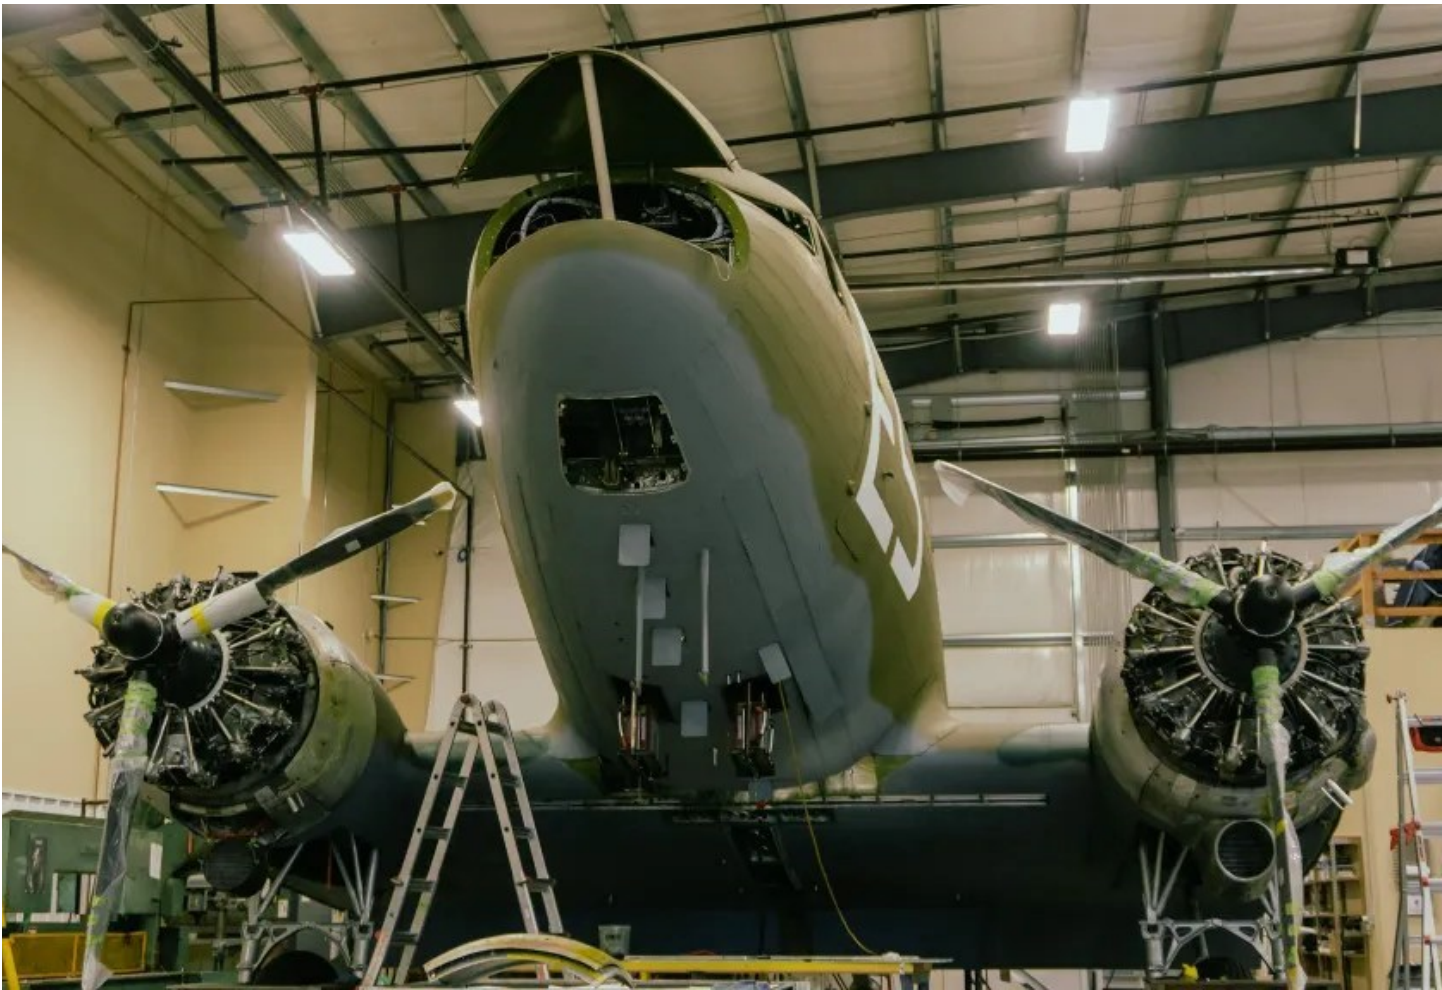
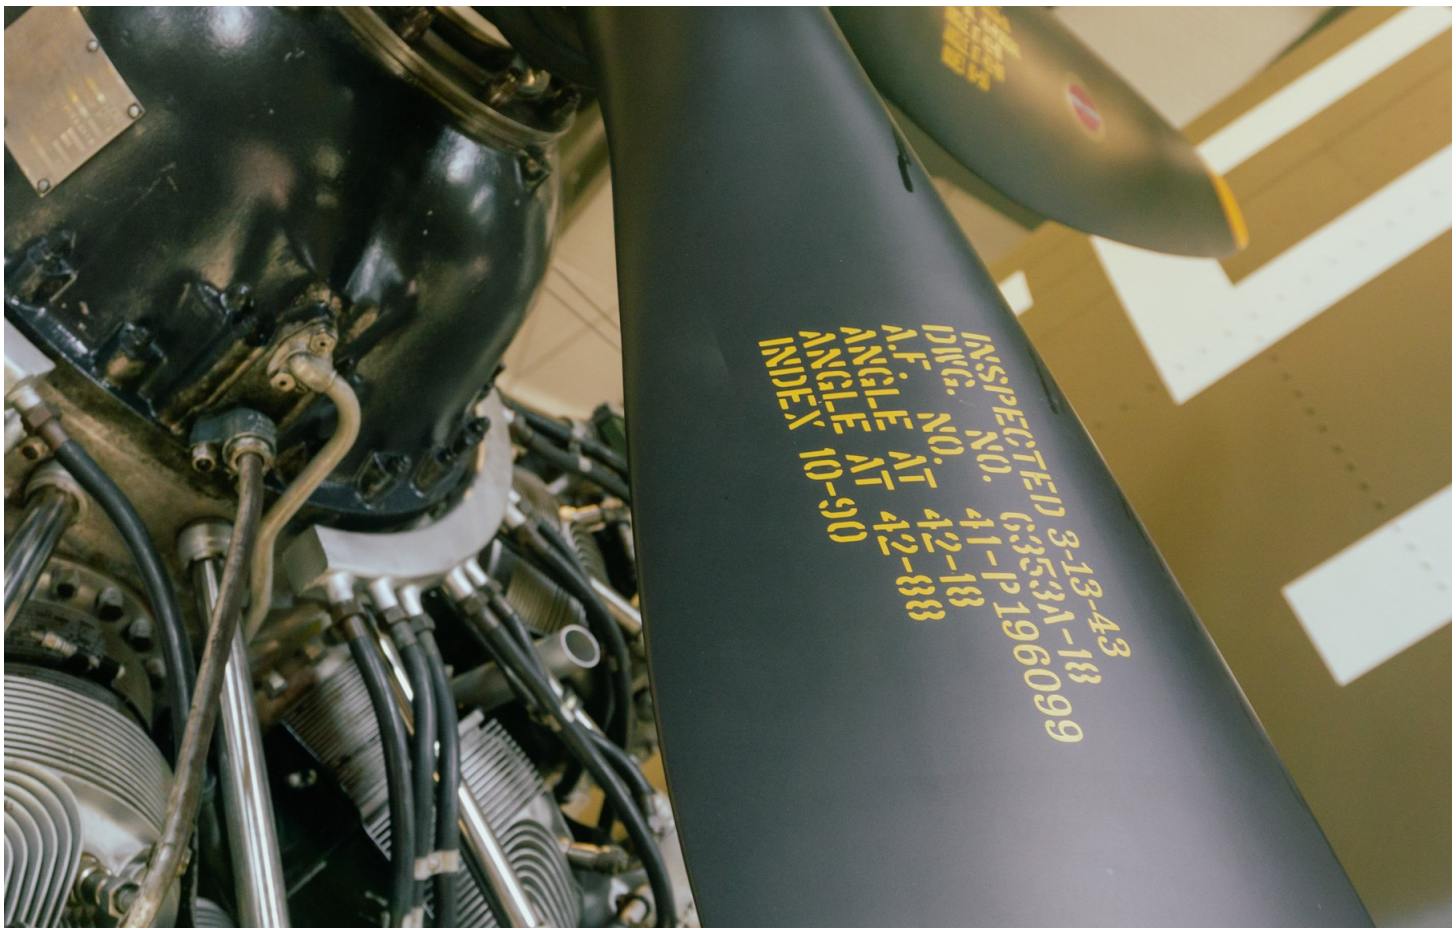
Engines and Propellers

Critical to the restoration project was the meticulous attention given to the engines and propellers. Engines were carefully removed from the airframe to facilitate necessary firewall repairs and underwent thorough inspections. Hoses and lines were replaced as needed. Propellers were sent out for comprehensive overhaul and compliance with AD requirements, meticulously stenciled according to original specifications. Engine and propeller control cables were remade as necessary.

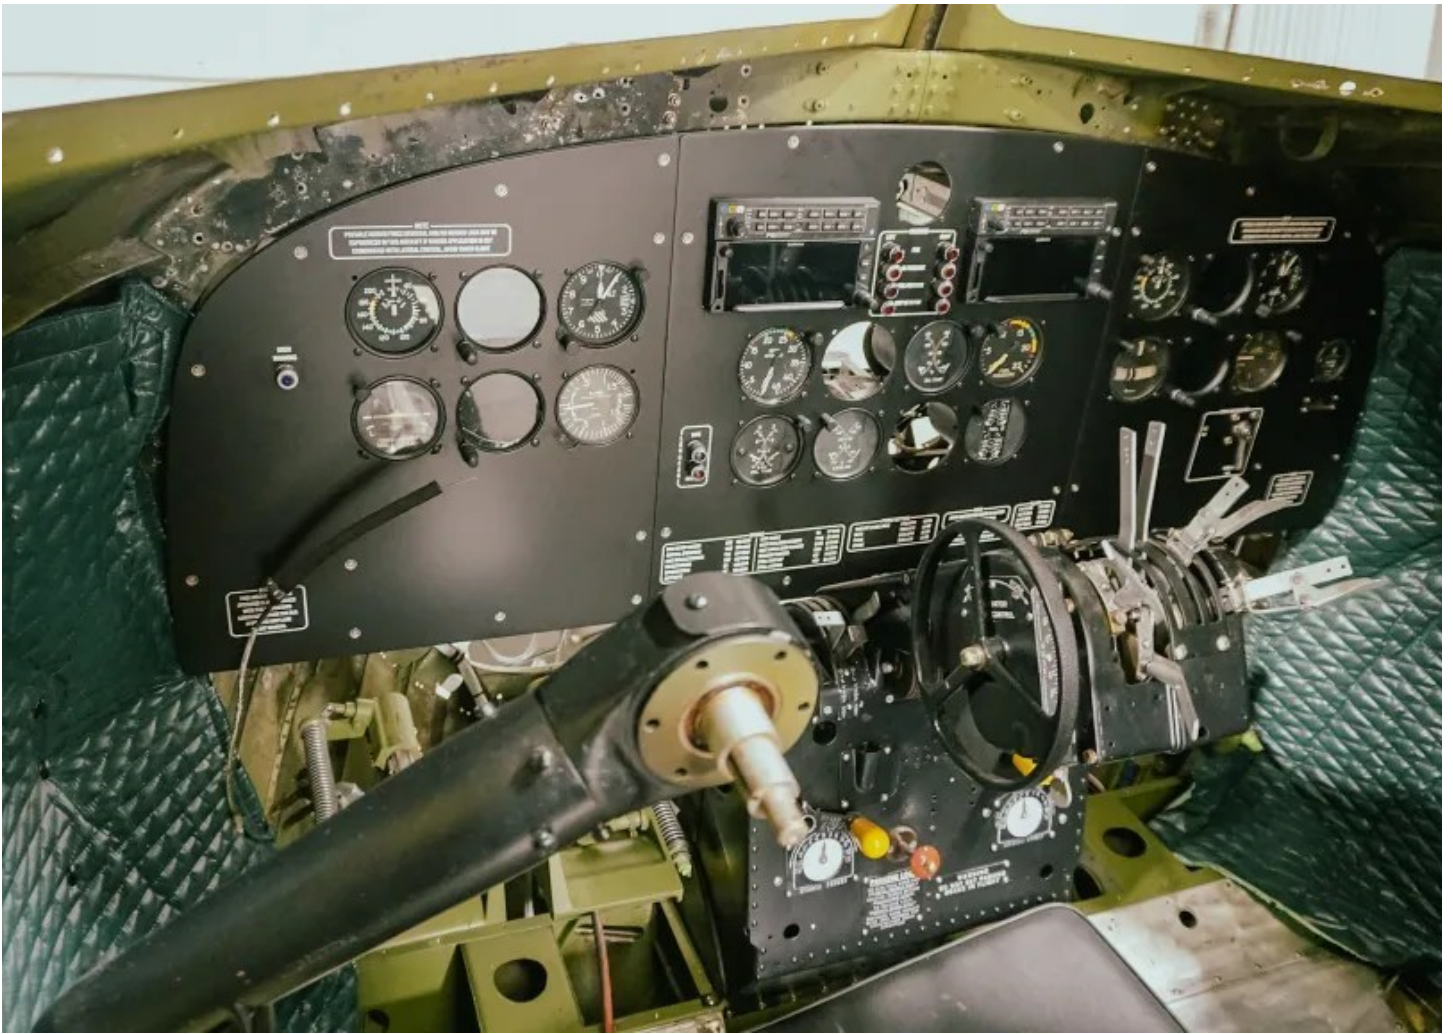
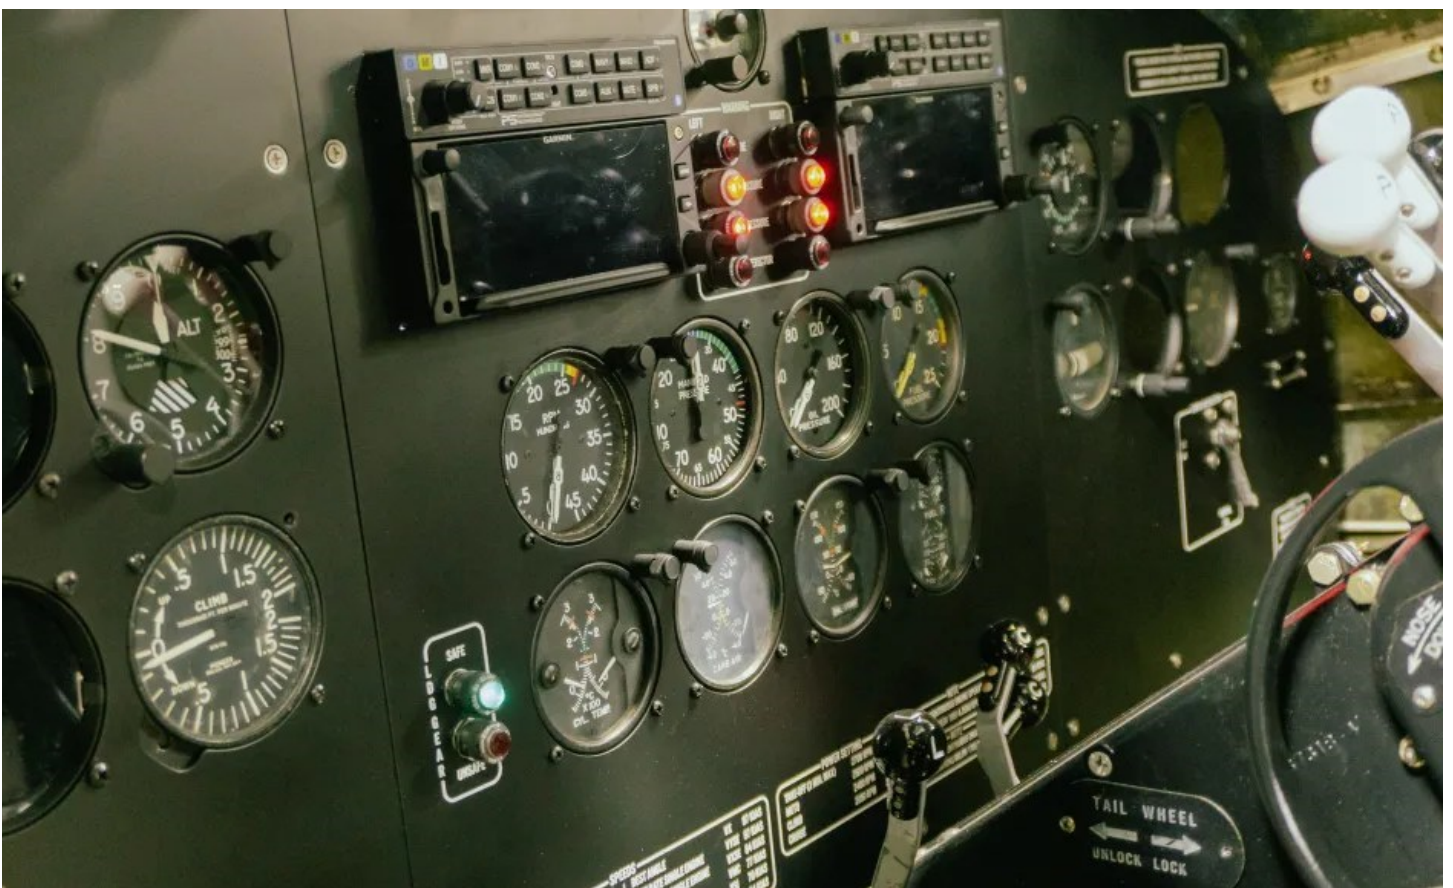
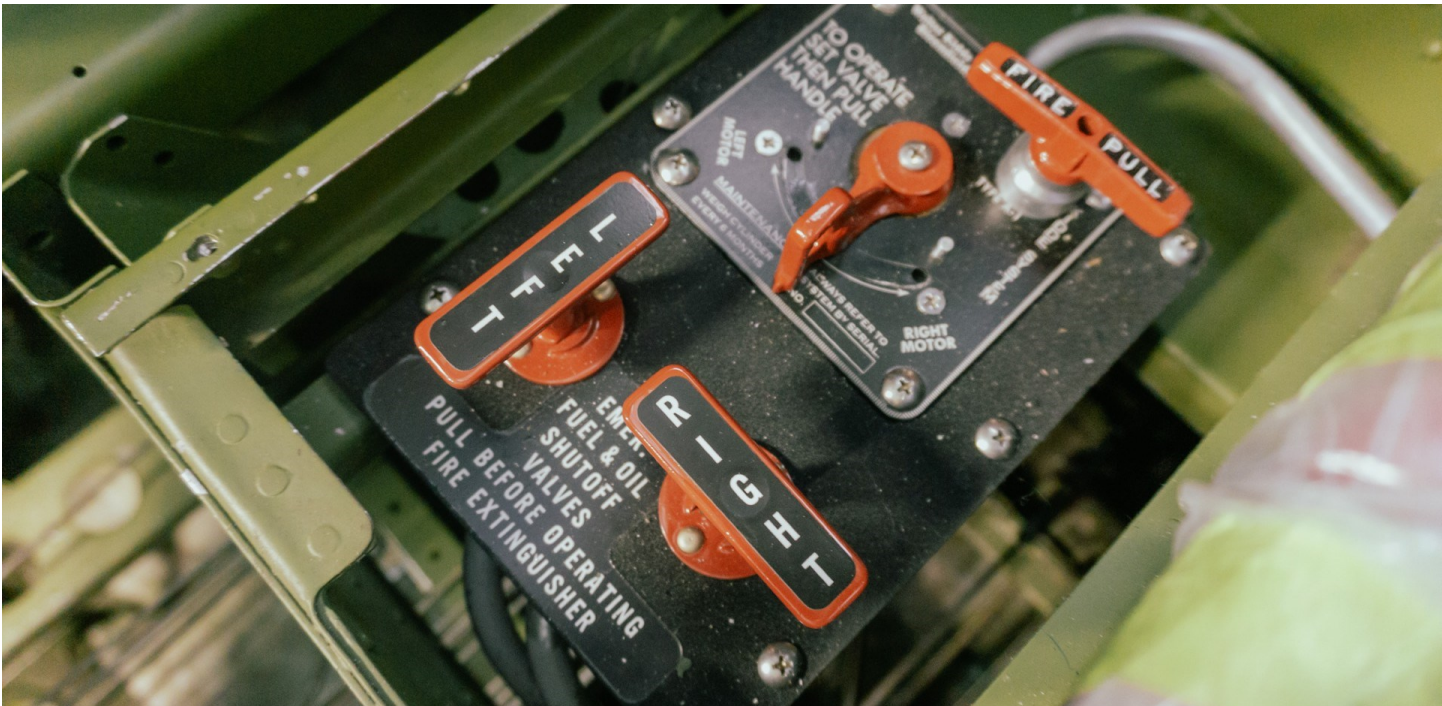
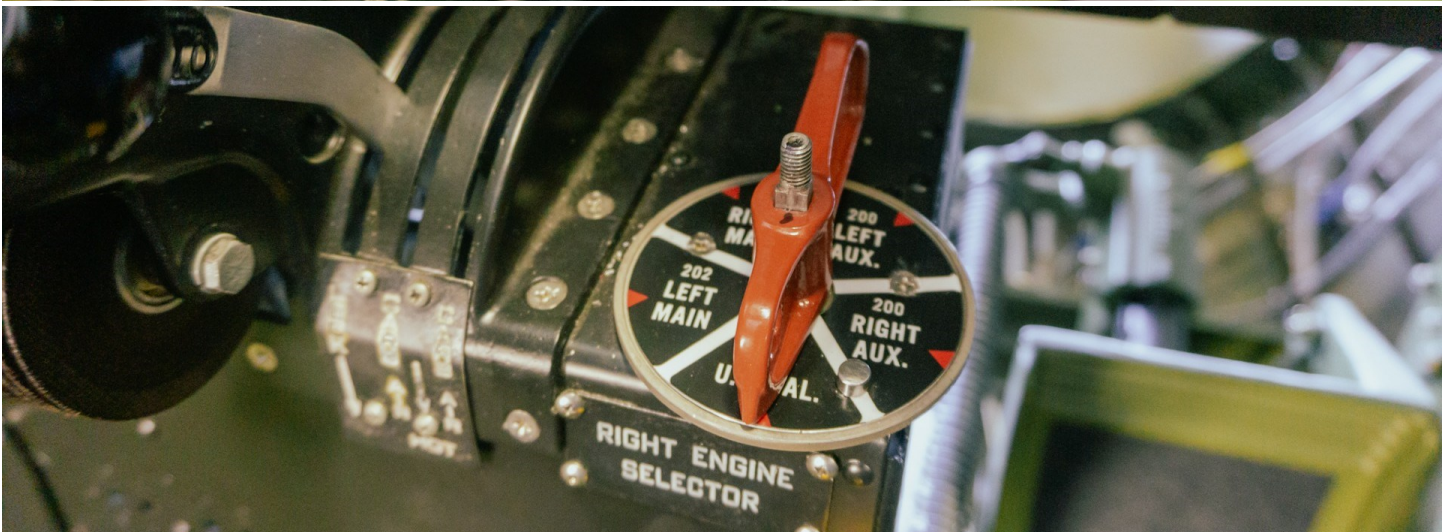
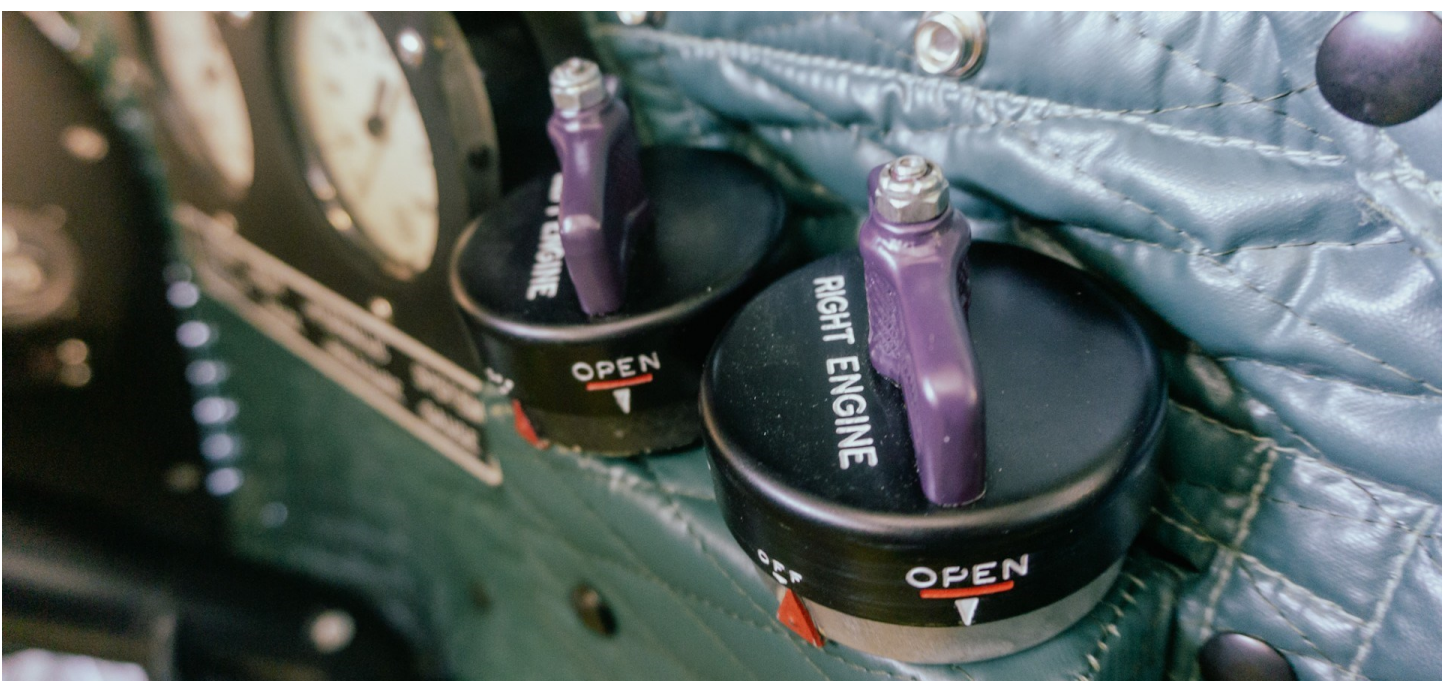
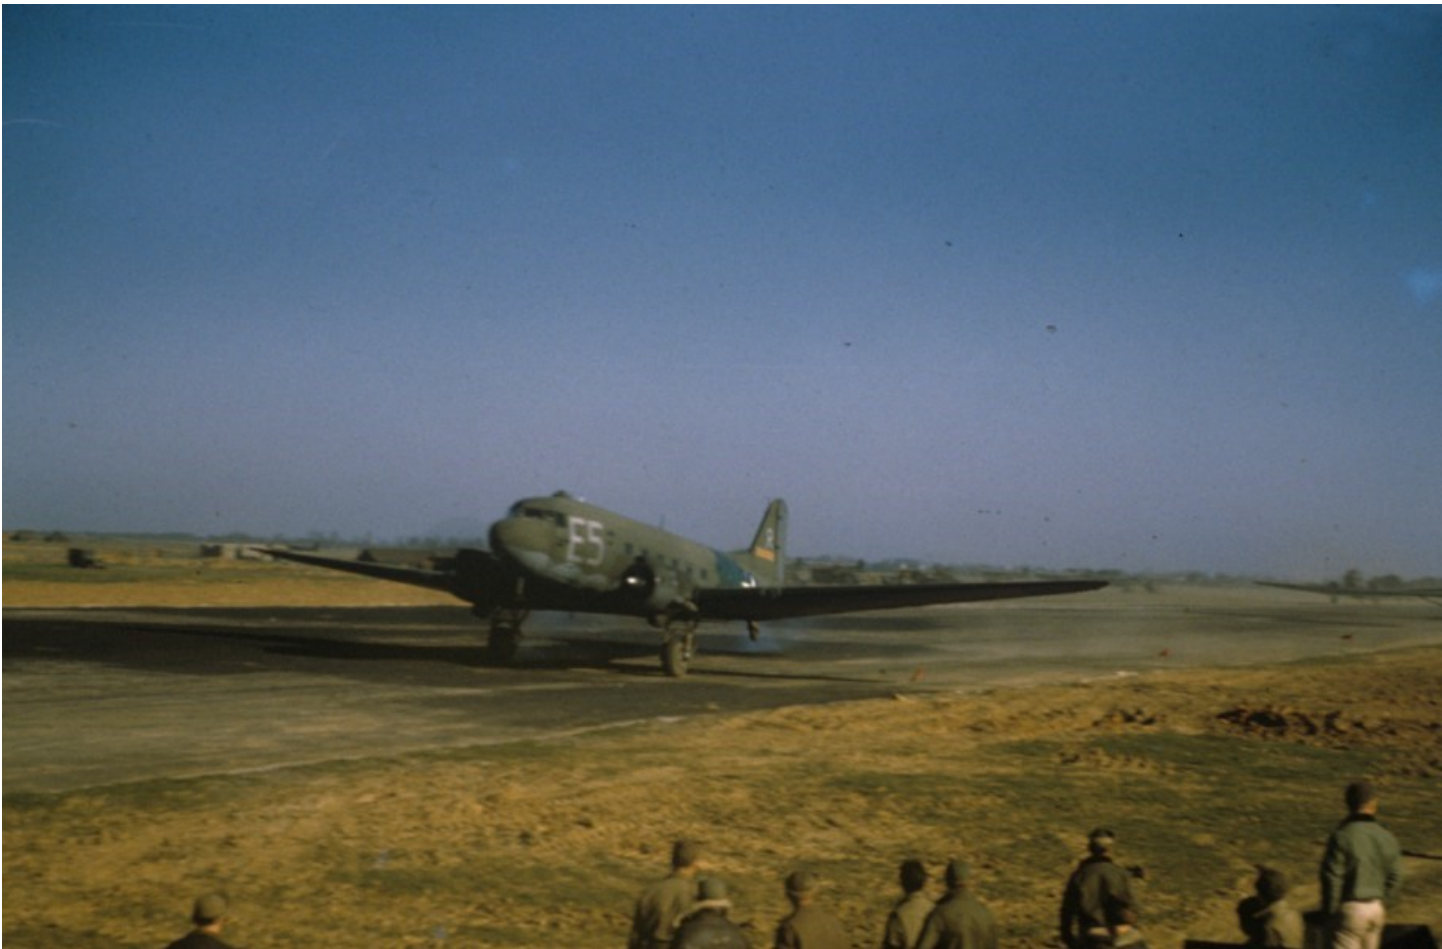
Flight Deck and Avionics

Modern avionics were integrated into the aircraft, maintaining its historical authenticity while enhancing operational capabilities. Upgrades included GI 275s and GTN650Xis, ensuring the aircraft's readiness for Instrument Flight Rules (IFR) operations. Attention to detail extended to features like cowl flap selectors, painted to original Douglas finish specifications, and preserving original paint on components such as firewall shutoff valves, flap, and gear handles, maintaining the aircraft's historical accuracy.

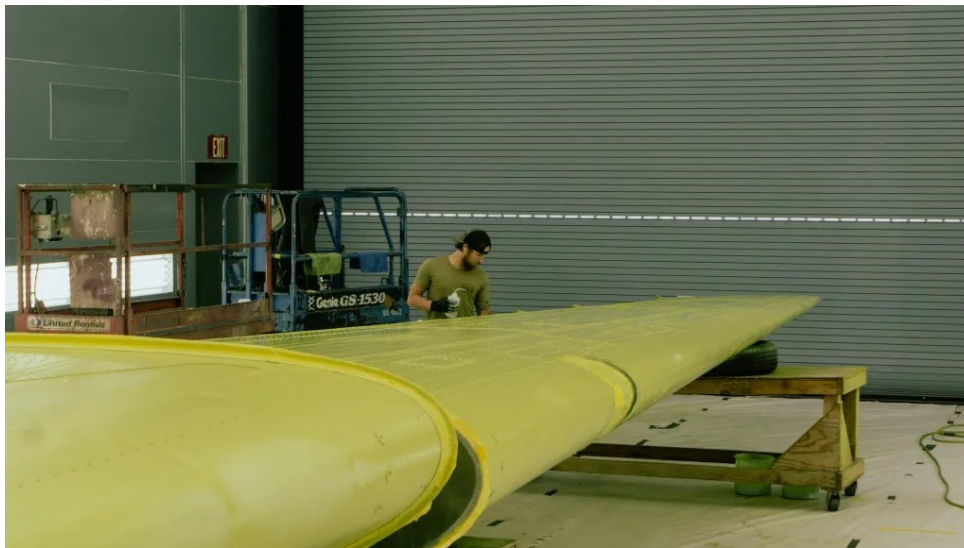
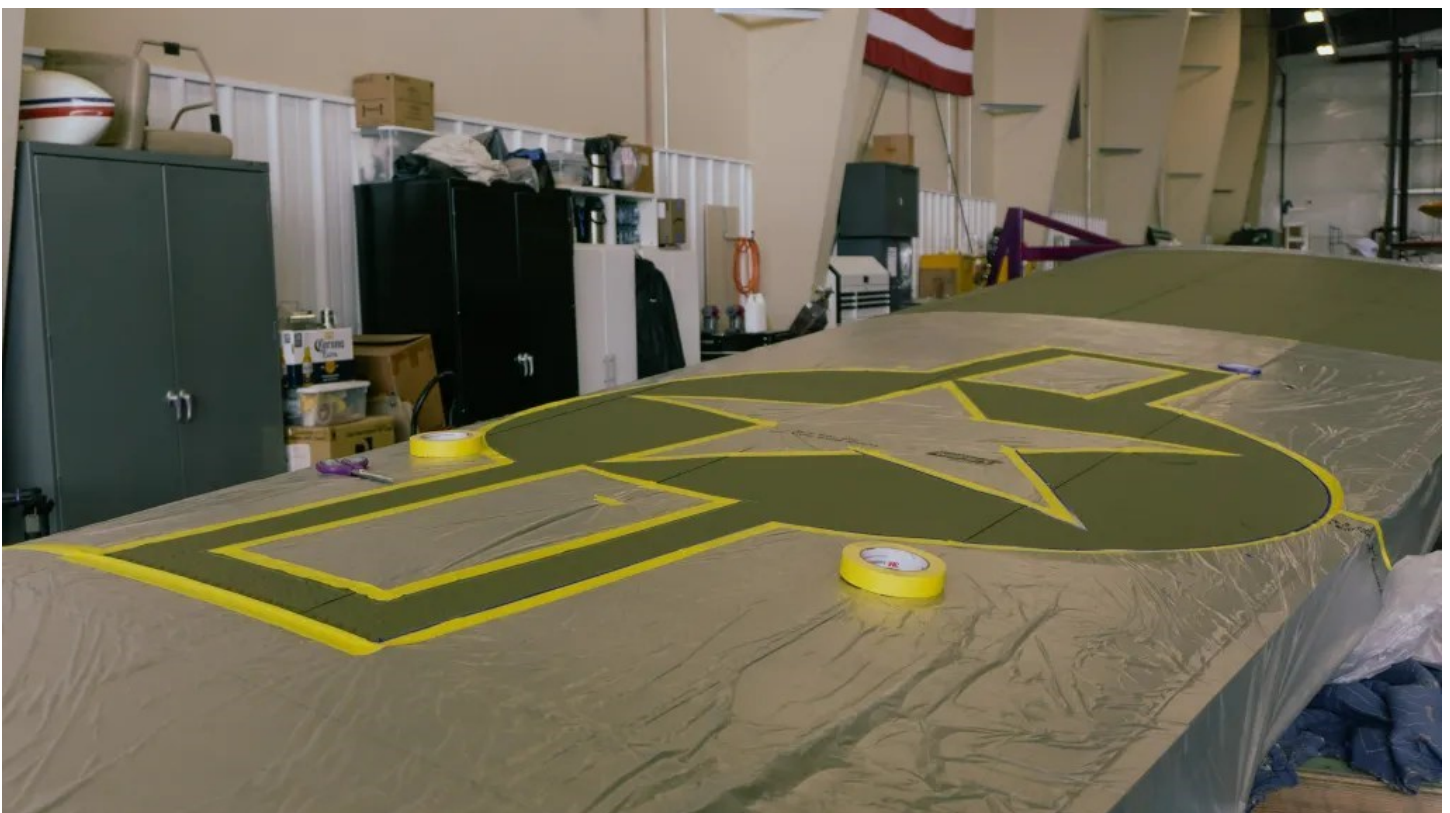
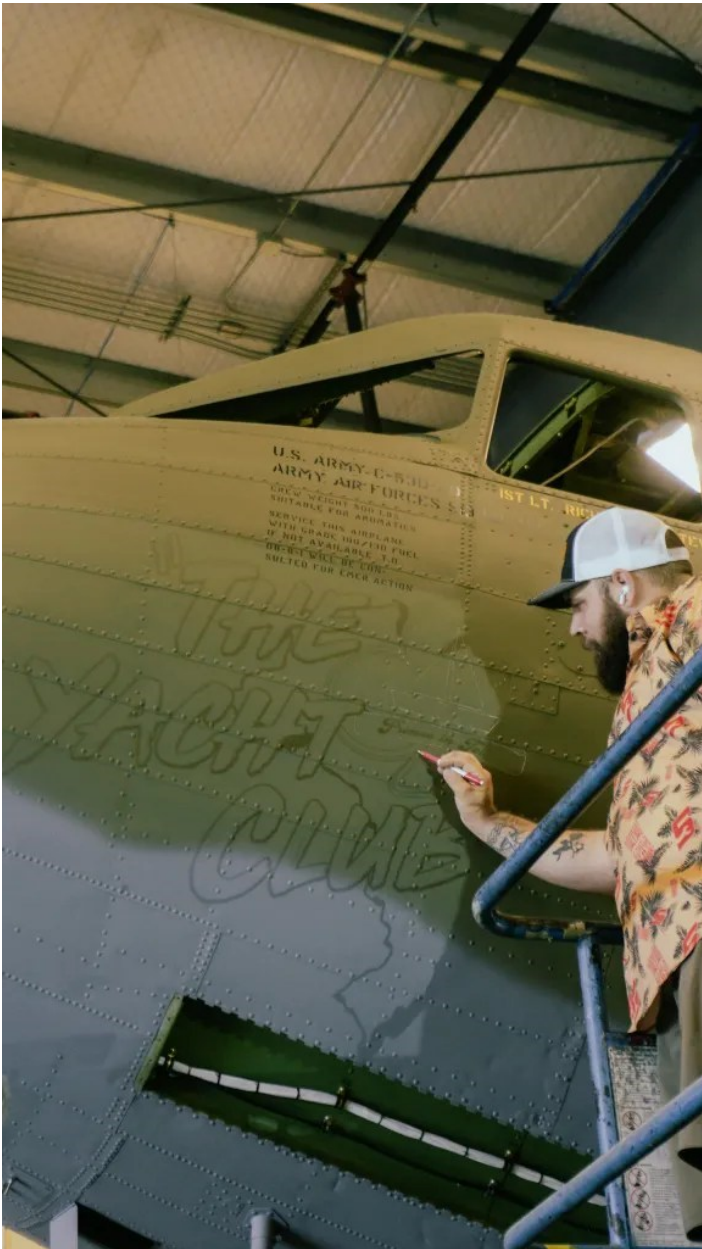
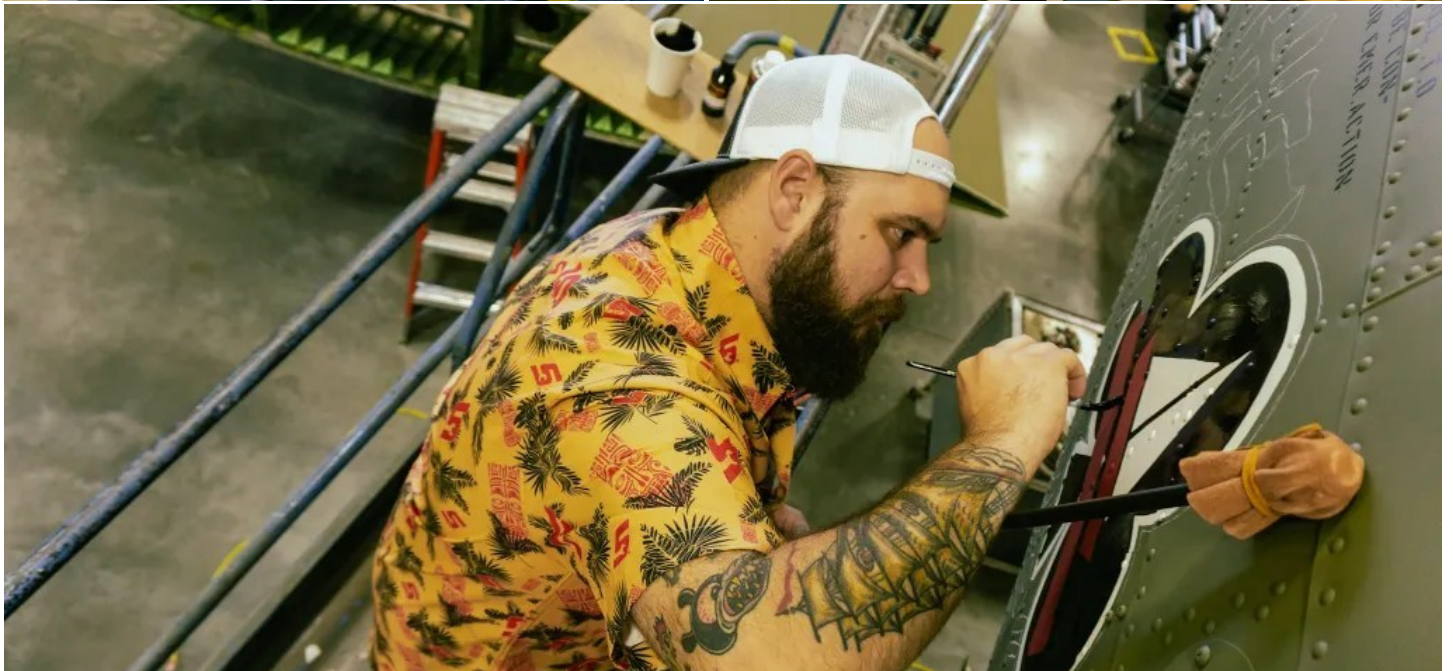
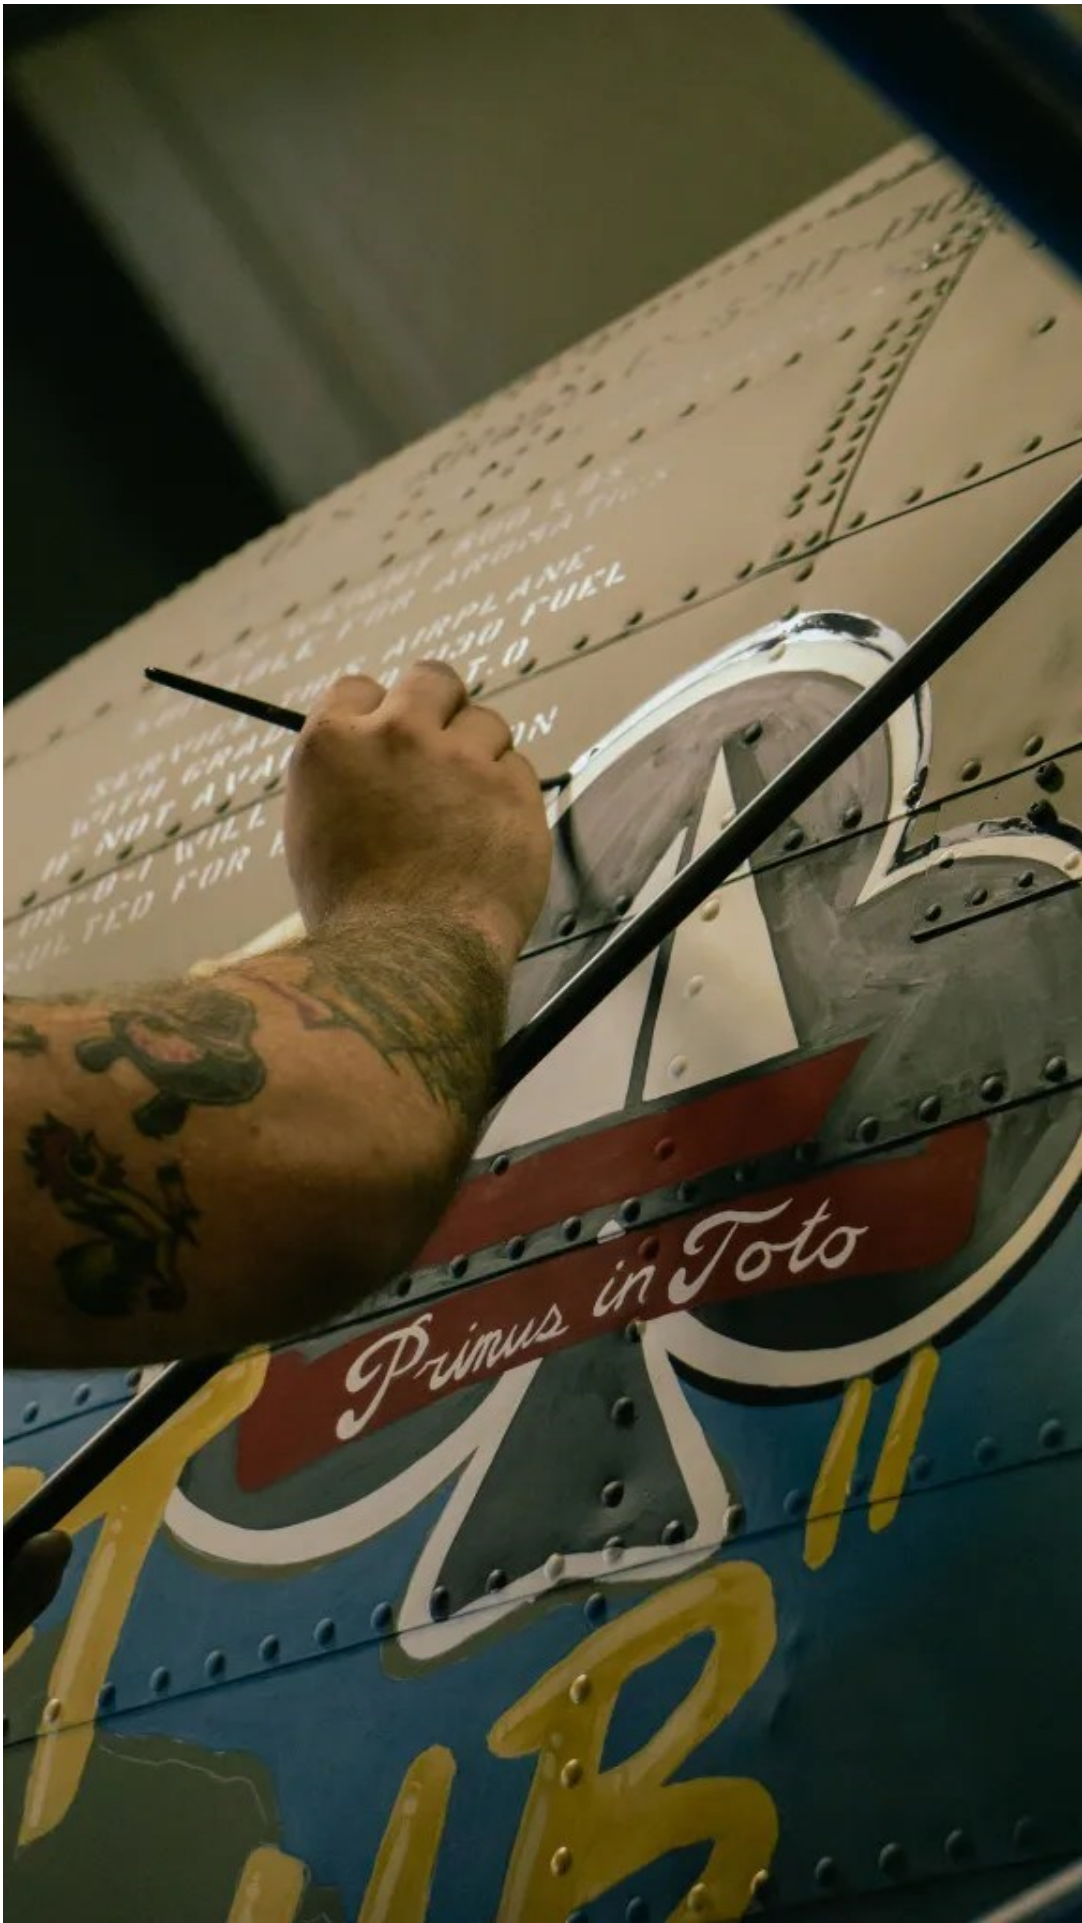
Livery and Exterior Details

The exterior restoration was carried out with utmost precision to reflect the aircraft's historical context and design. Painted in a proposed late-war livery, every detail was meticulously applied to original Douglas specifications. All exterior stencils were hand-applied using ink ordered to military specifications, ensuring accuracy and historical integrity. Notably, the aircraft proudly displays the Yacht Club nose-art, symbolizing continuity as the Yacht Club still exists today, using the same motto and expressing eagerness to host the airplane.
