TABLE OF CONTENTS

Airframe and General Structural Work

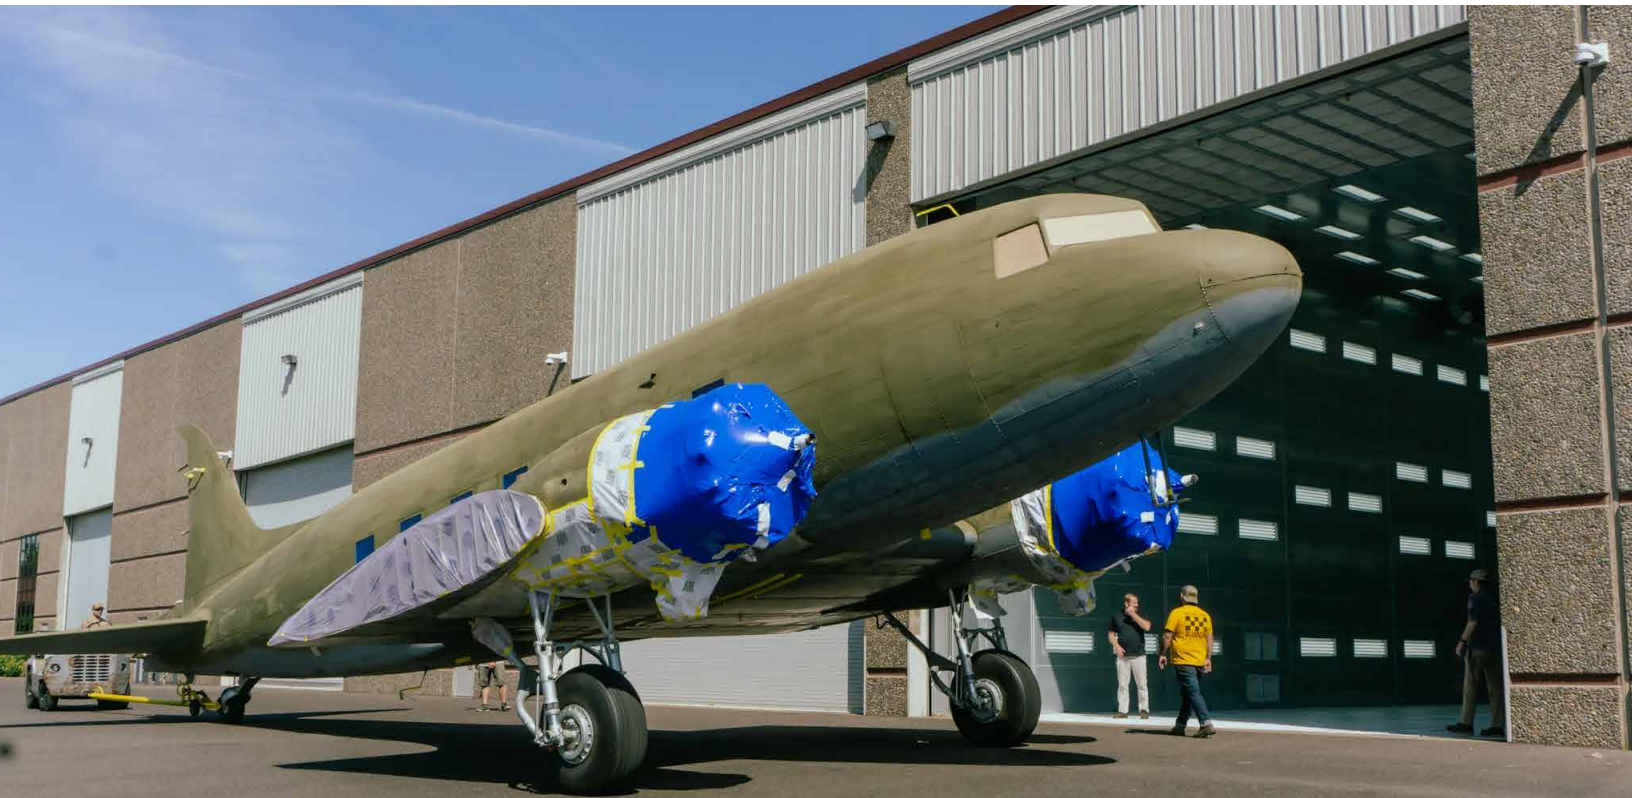
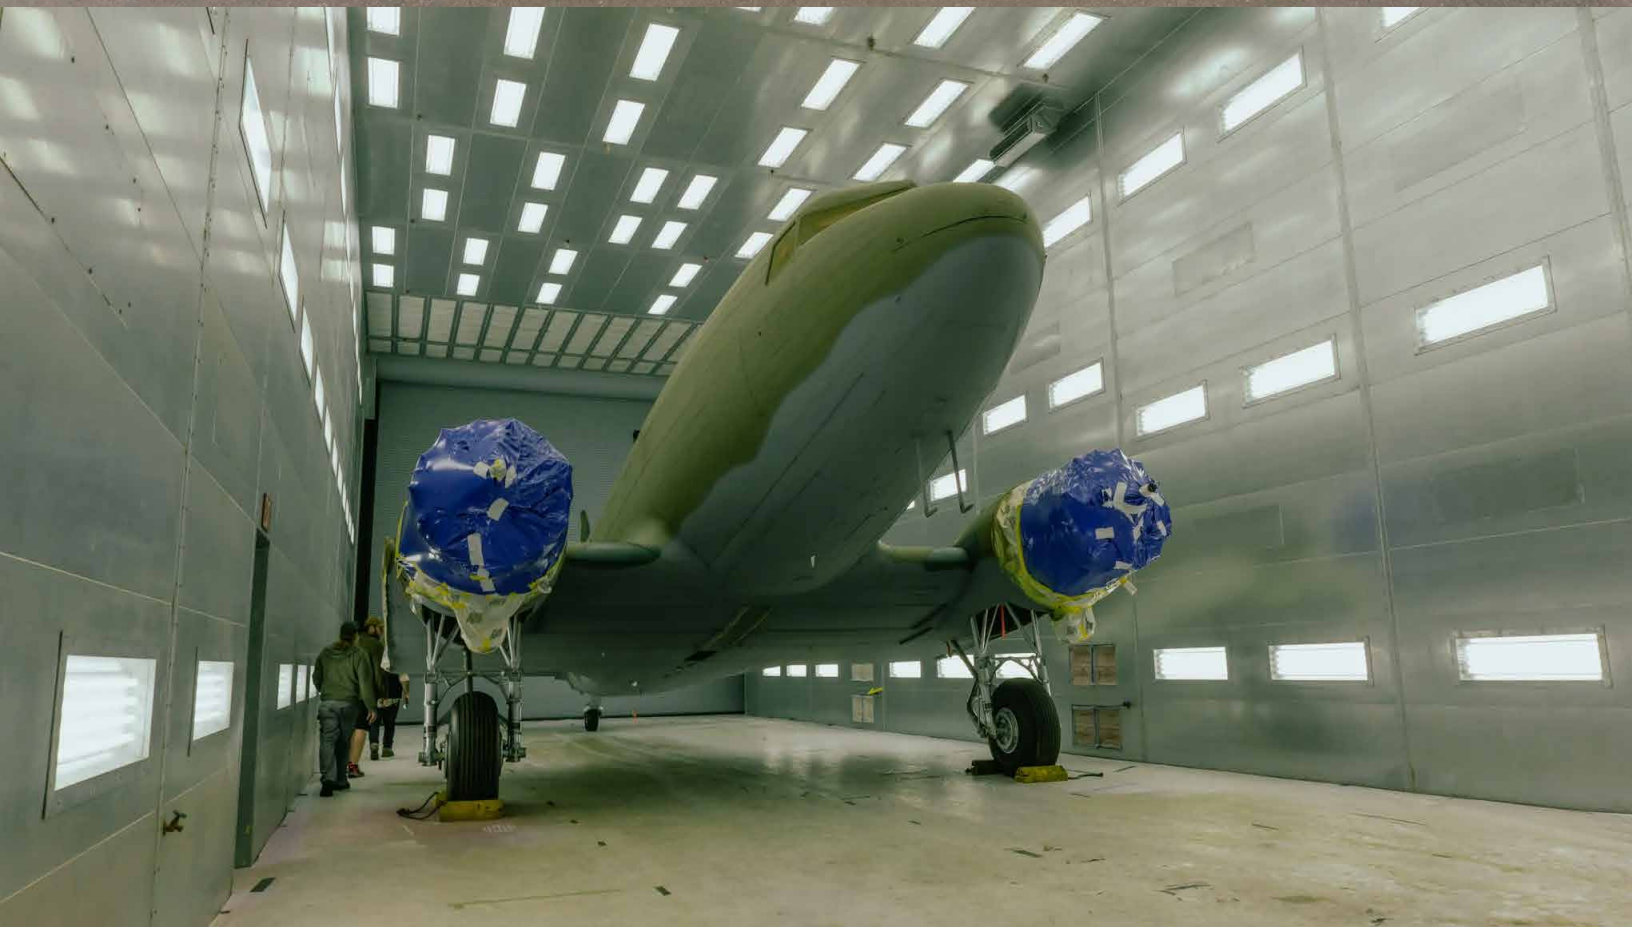
Reassembly and Final Checks

The final stages of reassembly were conducted with meticulous attention to detail and adherence to safety protocols. Engine runs were performed prior to wing installation to ensure optimal performance. Wings were installed and flight controls meticulously rigged to precision specifications. Interior installation included the placement of refurbished components and final adjustments. Rigorous final pre-flight checks were conducted to verify that every aspect of the restoration met exacting standards, ensuring both historical authenticity and operational safety.
